Safe Final Approach Considerations for ATC

Stabilised Approach — ATCO Guidance

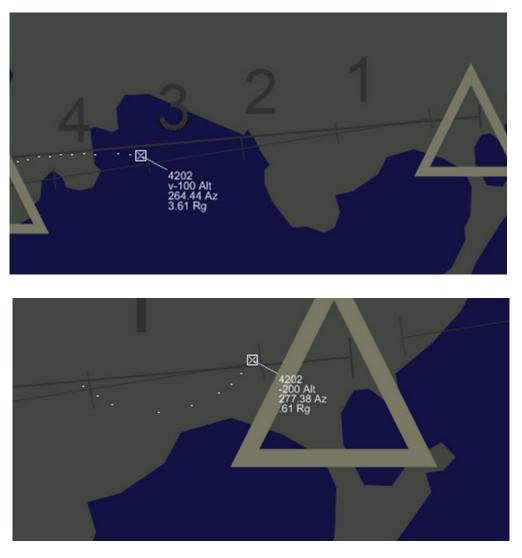
On the first two approaches, the pilot repeatedly failed to establish on the localiser and on both occasions was instructed by the Approach Controller to break off and be repositioned. On the third approach the pilot reported 'localiser established' and was transferred to Aerodrome Control but subsequently at 6 miles from touchdown initiated a descent well below the glidepath and then flew a very erratic lateral path.

Screen shots of the radar replay are shown below — the Aerodrome QNH was 1025 hPa and the altitudes depicted on the aircraft data label are based on 1013.2 hPa, so read approximately 300 feet lower than the actual altitude.

Whilst ATC positioning was not a contributory factor, the pilot was not warned of the aircraft's divergences from the approach path nor were any go-around instructions issued by either the Approach Radar or Aerodrome Controllers. See CAP493 Section 2, Chapter 1 - 19.5:

'A landing aircraft, which is considered by a controller to be dangerously positioned on final approach, shall be instructed to carry out a missed approach. An aircraft can be considered as dangerously positioned when it is poorly placed either laterally or vertically for the landing runway.'

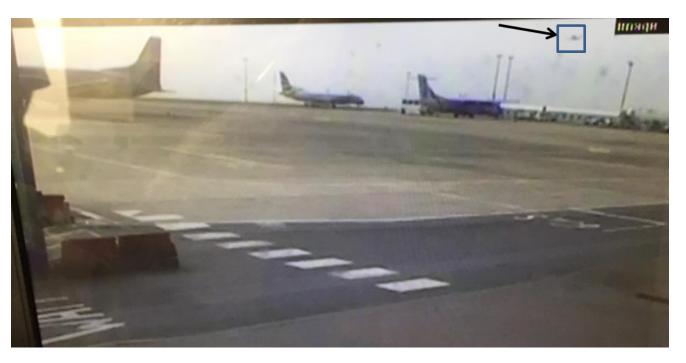
CCTV screen capture with the PA32 aircraft highlighted by arrow and square in top right corner tracking northeast:

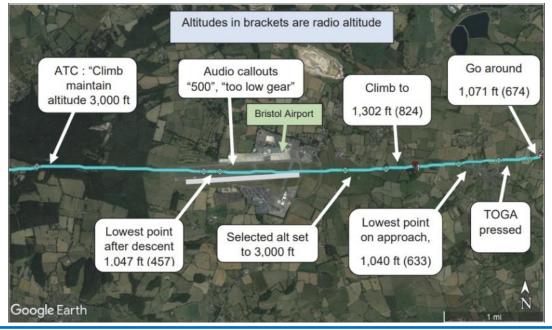
Still at idle thrust and at an excessive airspeed, this descent was established at approximately 250 ft below the procedure vertical profile. As the MDA was approached, the 'ALT AQ' mode activated causing the rate of descent to decrease but it still remained significantly below profile and also still below the applicable Minimum Obstacle Clearance Altitude.

At this point, the TWR controller was involved with an aircraft push back problem on the apron but the Assistant present had become concerned by what they considered was the unusually low altitude of the 737 and drew the controller's attention to it. The controller stated that on looking, he had considered that the aircraft was 'dangerously positioned' as defined in the MATS Part 1 and had 'instinctively instructed the crew to go-around' - the aircraft was at 2nm from touchdown. This instruction was acknowledged and a go around commenced with the First Officer flying manually by reference to the flight director and take off/go-around thrust selected . However, because the MDA rather than the go-around stop altitude was still the selected altitude, the flight director command had changed from a climb to a level off on reaching MDA. As it did so, the auto-throttle mode changed from 'go-around' to one which maintains the current airspeed and this led to engine thrust reducing below 20°. Further difficulties were encountered by the flight crew resulting in the aircraft descending and reaching a minimum of 457 feet agl.
