Kionslieu Reservoir

Discontinuance Feasibility Assessment Report

| Document Title: | Discontinuance Feasibility Assessment Report |
| Project No: | P1077 |

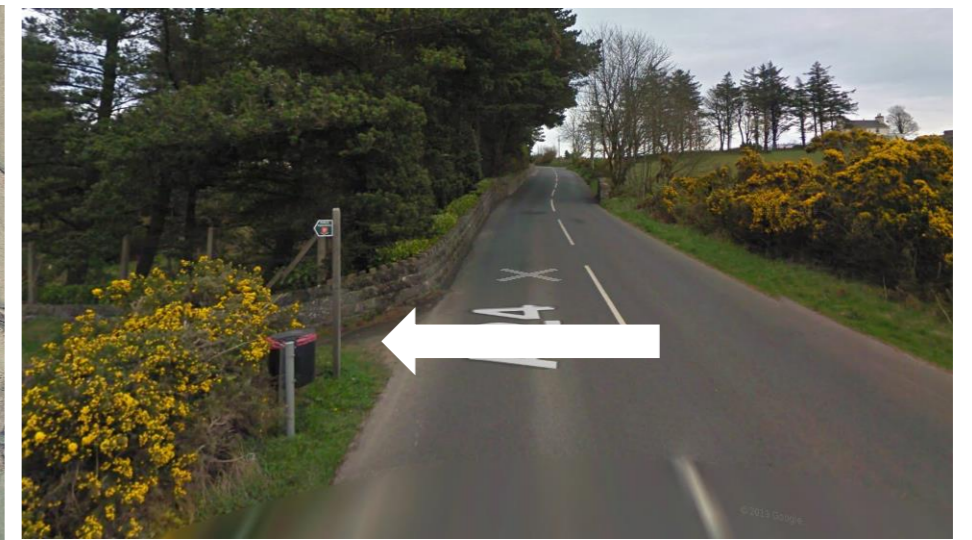
The existing cycle track to the reservoir western embankment crest was observed to be narrow with an uneven profile, but overall good condition. The track is not adequate for Private / Light Goods Vehicles (P/LGVs), Heavy Goods Vehicles (HGVs) or any specialist 4x4 vehicles and can currently only be used for pedestrian/cycle access.

Entrance to existing cycle track leading to west embankment (looking East)

- Installation of a permanent stone track surface along the existing cycle track (geotextile, granular fill, hardcore and stone) on the western embankment.
- Temporary access tracks will need to be completely removed on completion of the works and the area returned to its pre-scheme condition.
- Permanent access tracks will need to be cleared of any construction debris and made good on completion of the works.

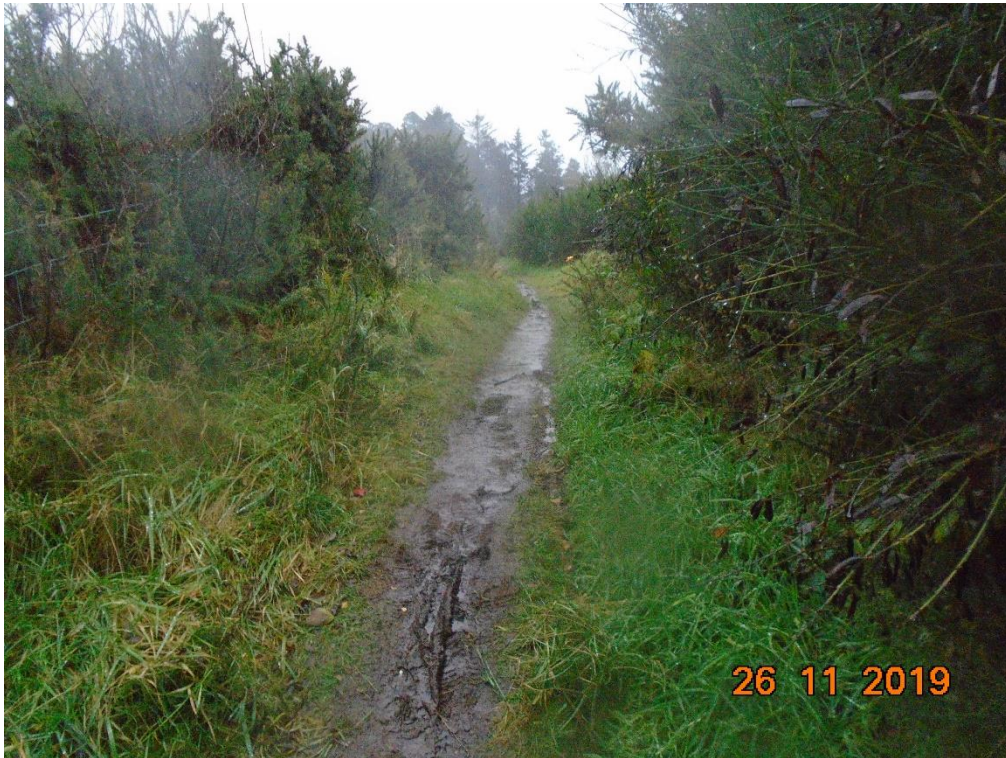
| Feature/consideration | Condition/observations |
|---|---|
| Western Embankment - Crest | <i>Wide crest with fence along downstream side. Heavily overgrown constraining the footpath/cycleway which has become excessively worn and rutted prior to January 2020. Soft and extremely muddy in places at the time of both visits. No indications at any location of movement or settlement. See Photograph 3.</i> |

Photograph 3: Crest of western embankment. Fence and downstream slope on left of photo.

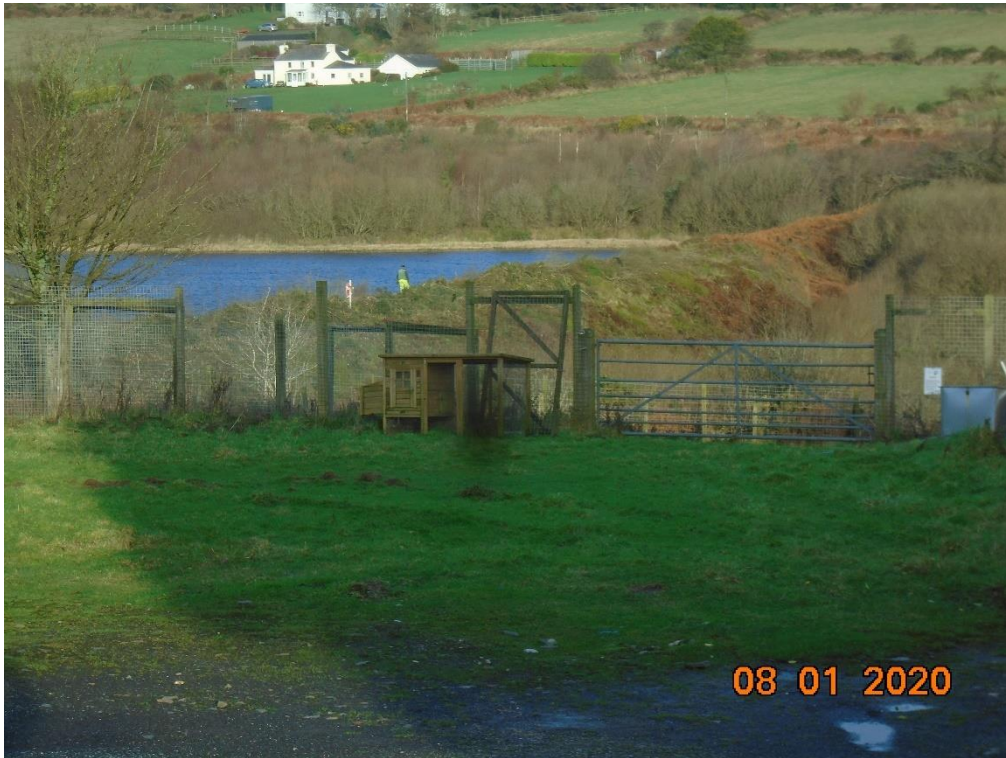
| Feature/consideration | Condition/observations |
|---|---|
| Eastern Embankment - Downstream face | <i>Sufficiently cleared in January 2020 to allow access. Oversteep, say 1V:1.5H. No signs of movement or slipping. No indications of seepage through the embankment. However, toe area waterlogged and boggy which could possibly indicate seepage at a low level or through the foundations. Further investigations would be needed if a retain option is adopted. See Photographs 5 and 8.</i> |

Photograph 5: Upstream face of eastern embankment.

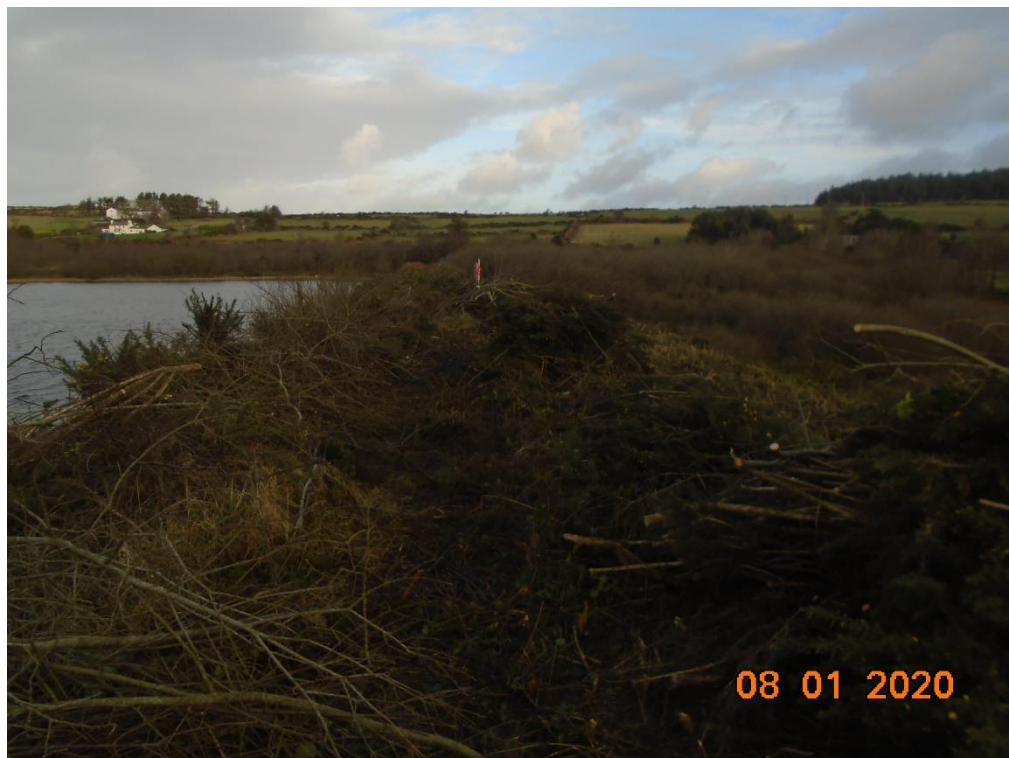
| Feature/consideration | Condition/observations |
|---|---|
| Eastern Embankment - Crest | <i>Largely cleared in January 2020. Dense vegetation has prevented access, keeping crest in a generally satisfactory condition. No signs of movement or settlement. A central section of the embankment, at the outlet/overflow structure, appears to be lower than the main embankment either side, and would thus tend to operate as an auxiliary spillway. Levels would need to be confirmed with a topographical survey. See Photograph 7.</i> |

Photograph 7: Crest of eastern embankment.

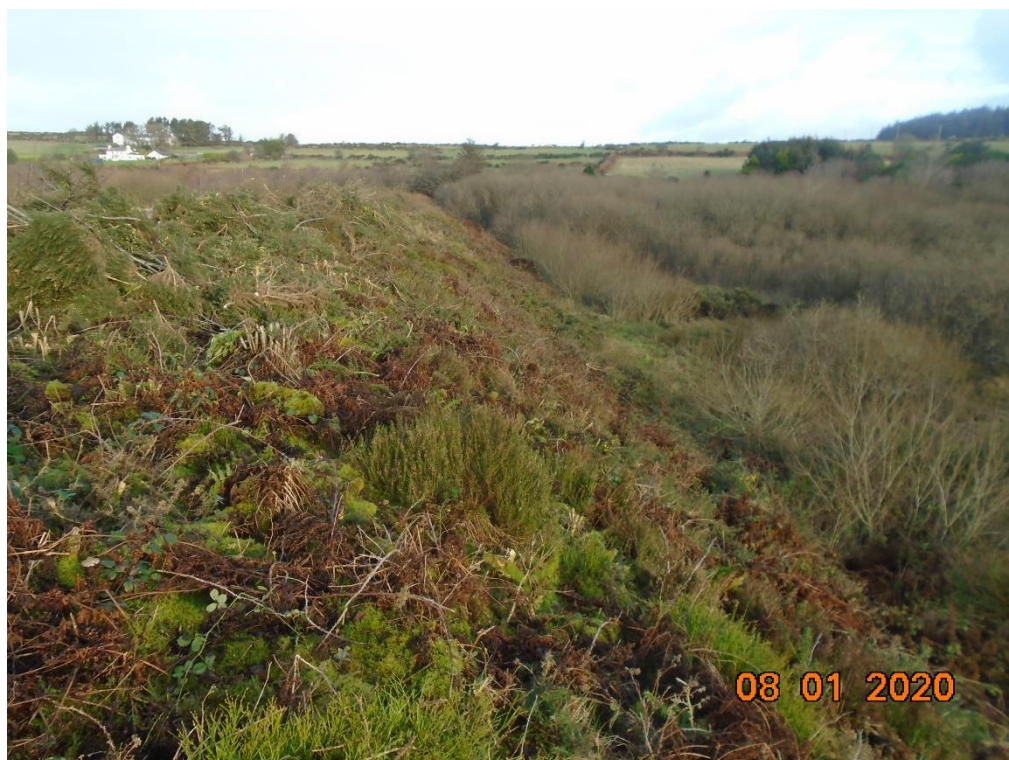
Photograph 8: Downstream face of eastern embankment.

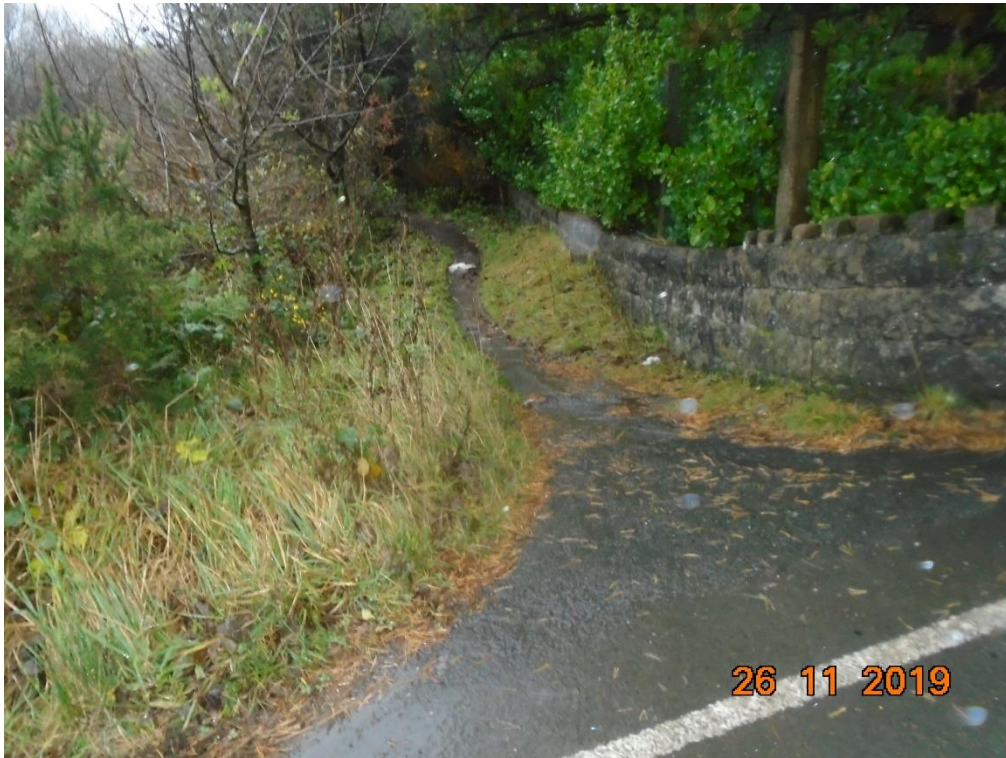
| Feature/consideration | Condition/observations |
|---|---|
| Access | <i>Access on to the western embankment crest available using existing public footpath/cycleway off A24 Foxdale Road. Footpath in poor condition, heavily rutted, soft and muddy on day of visit. Access to eastern embankment only through private land (residential property), through old gateway off A24 Foxdale Road. No access on to embankment due to dense vegetation. See Photographs 11, 12, 13..</i> |

Photograph 11: Footpath/cycleway access to western embankment from A24 Foxdale Road.

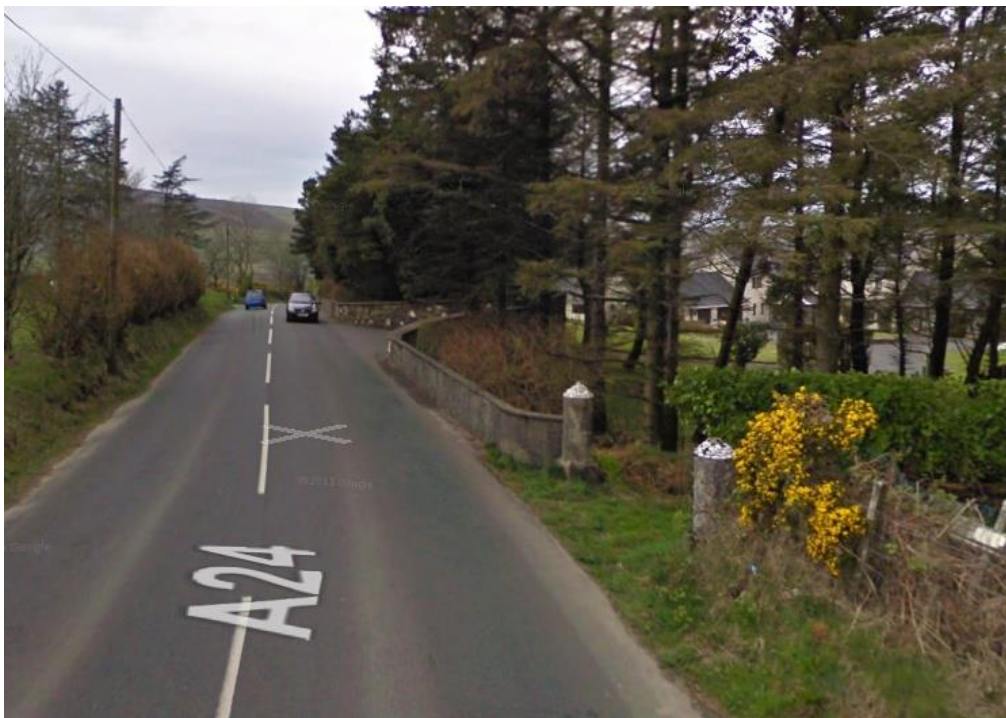
Photograph 12: Gateway into private land for access to eastern embankment.

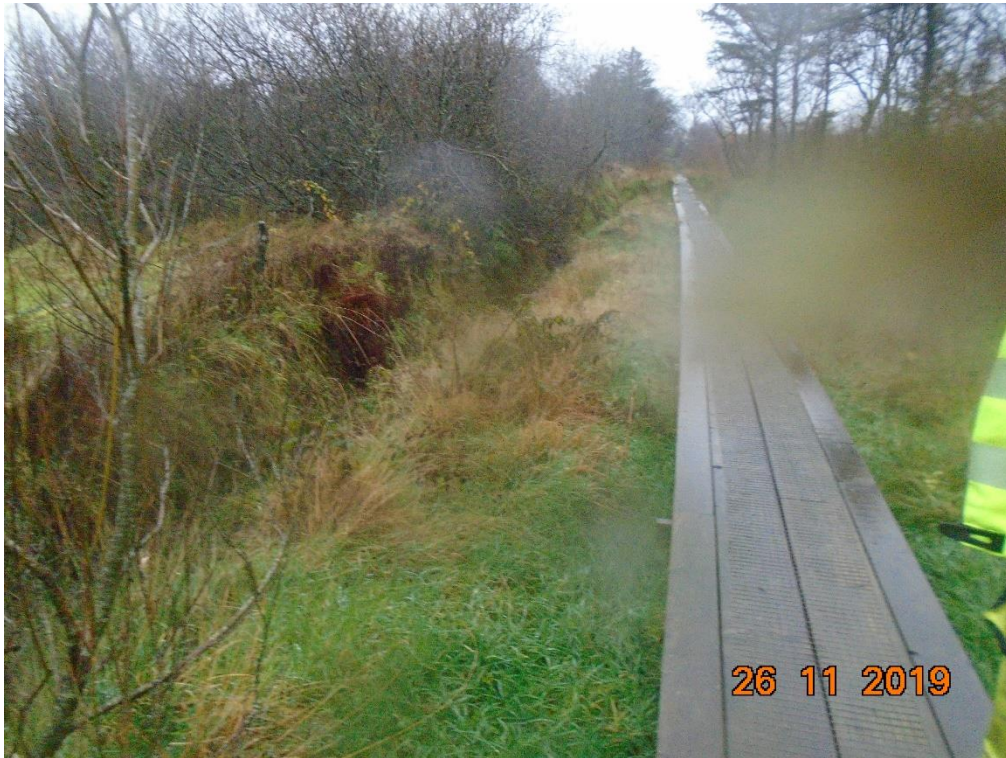
Photograph 13: Boardwalk/cycle track around north-western area of reservoir.

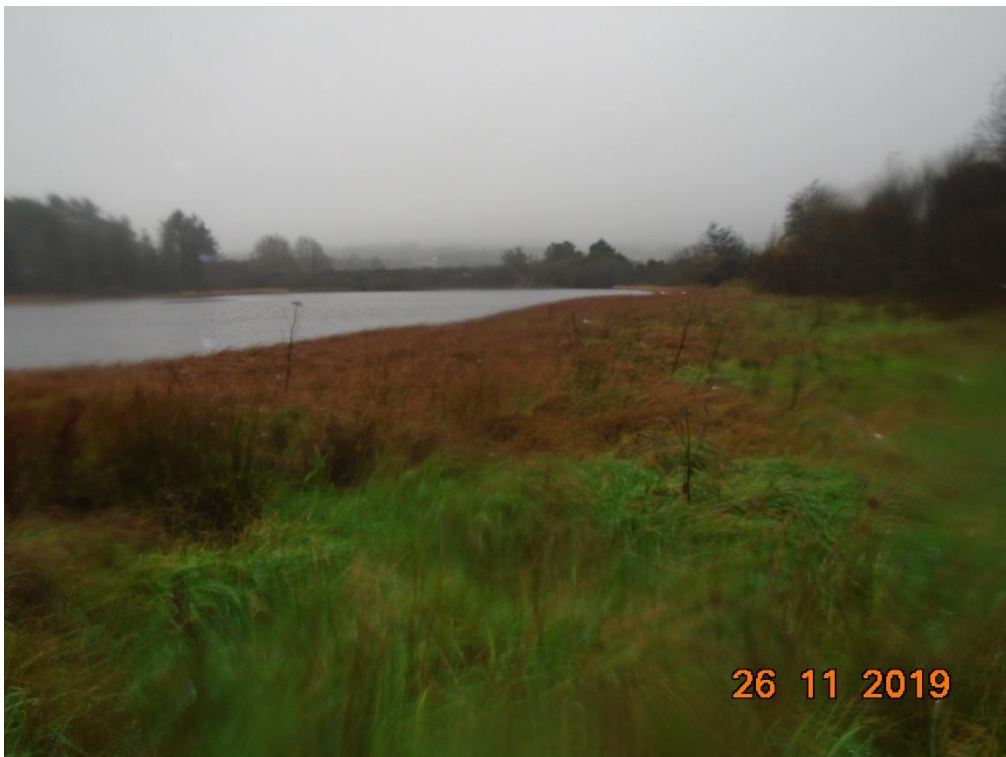
| Feature/consideration | Condition/observations |
|---|---|
| Surrounding slopes | <i>Bankside areas are gently sloping into the reservoir basin. No stability issues are anticipated and no signs of movement or slips in surrounding land. See Photographs 14 and 15.</i> |

Photograph 14: Bankside area – north-western side of reservoir.

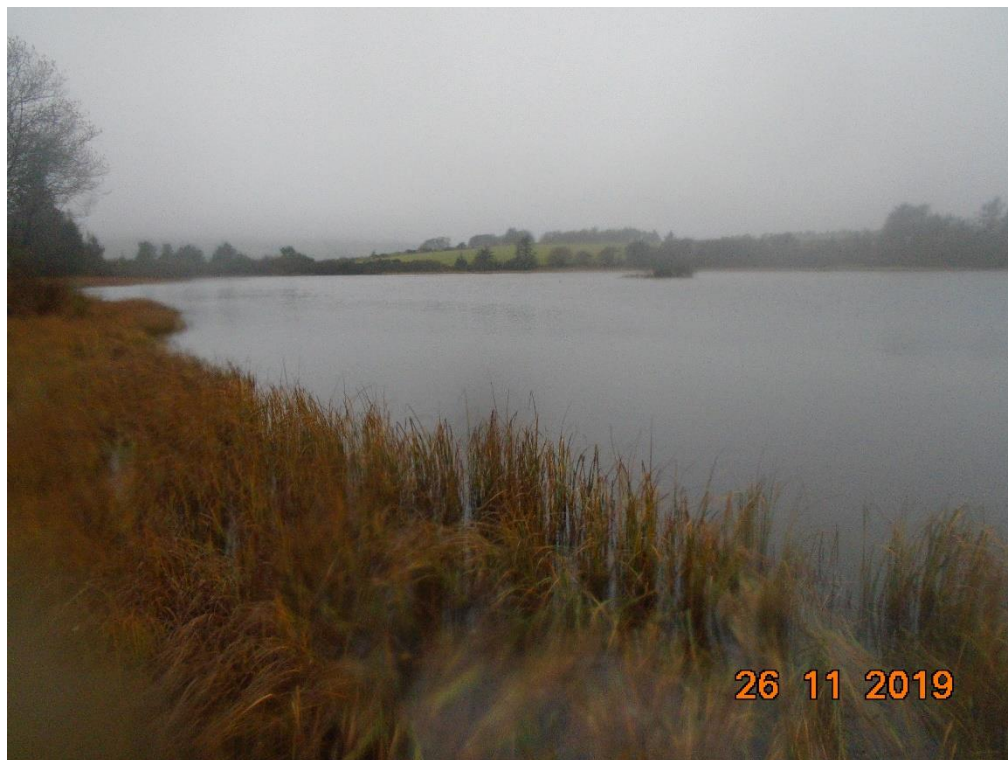
Photograph 15: Bankside area – south-eastern side of reservoir.
