NOTICE IS HEREBY GIVEN that at a meeting held on the 21st October 2014, the Department of Infrastructure, in pursuance of its powers under the above Acts and Regulations REGISTERED

Railway Station Main Road Santon Isle Of Man IM4 1EH

REGISTERED BUILDING PROPOSAL

Santon Railway Station

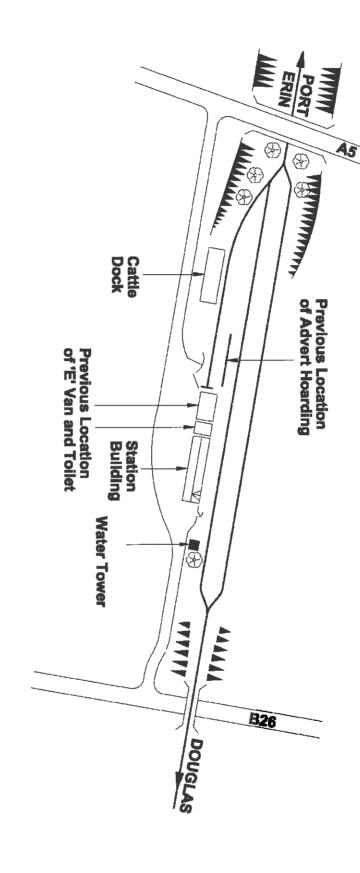
DRG. No. SA-001 Rev. 'A'

As can be seen in the layout drawing herewith (SA-001) the station site consists of a passing loop and a siding which once served a Cattle Dock. The 'manure' siding, cart road and cattle dock were added in 1910, subsequently an advertisement hoarding hid it from the train. The cattle pen has long since gone, but the stone platform remains and is still used today for loading permanent way wagons. The station building has a wooden frame to which overlapping wooden planks (weatherboard) are attached, the roof is corrugated steel. The detail drawing SA-002 illustrates the building circa 1960 with the brick toilet and former 4-wheel brake that once existed alongside the building. The van was E4 which was moved here in 1924, lifted off its underframe and

SANTON STATION LAYOUT (Not to Scale)

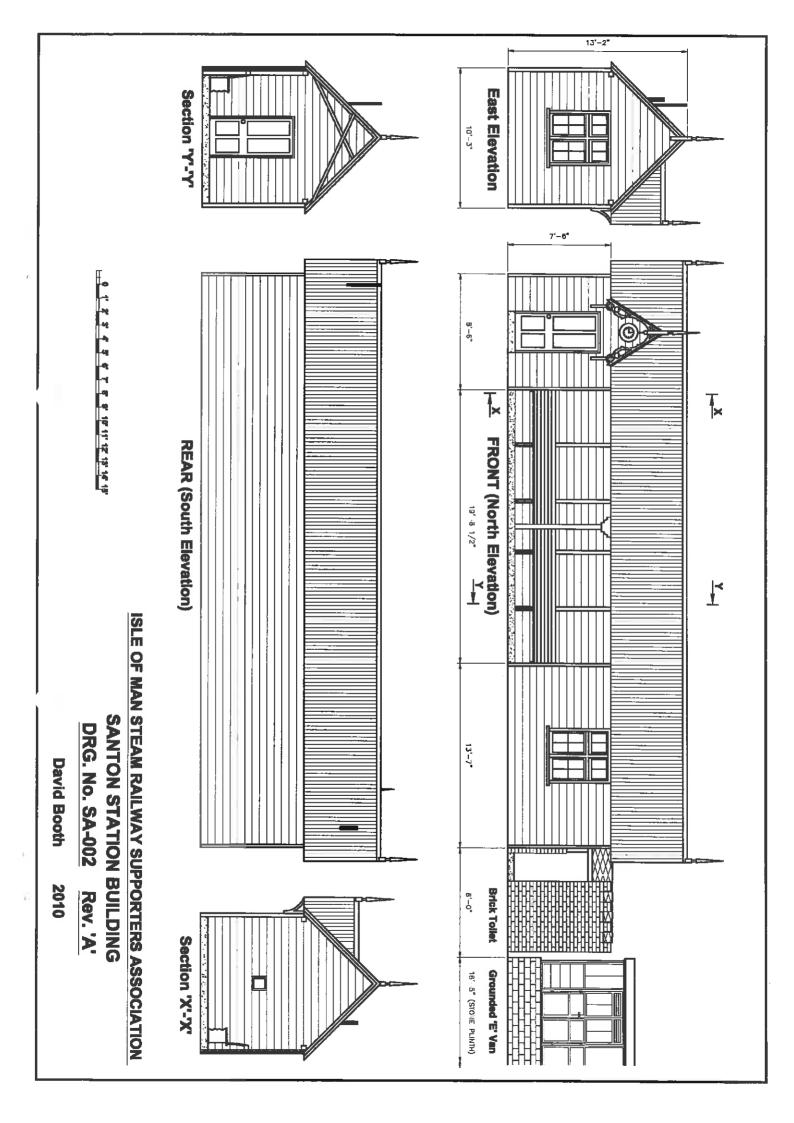
Currently the station building is in reasonable order, although it has not had any work done to it since 2002 when the roof was repaired and the woodwork repainted. The building itself is more or less in the condition illustrated in drawing SA-002, however the station clock has long since disappeared and the windows are usually covered with wooden shutters.

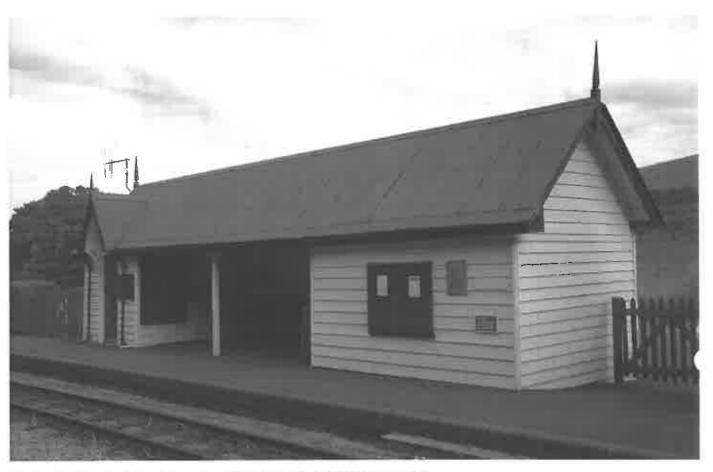
Santon Station Building taken from the platform side looking south.

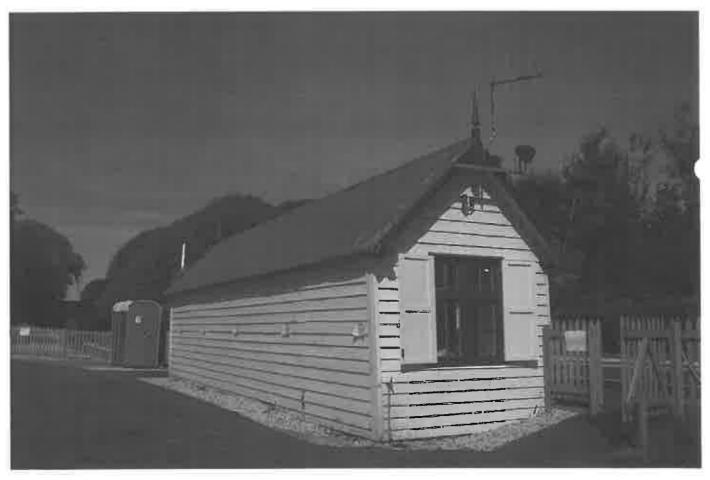
The rear of Santon Station Building looking north east.

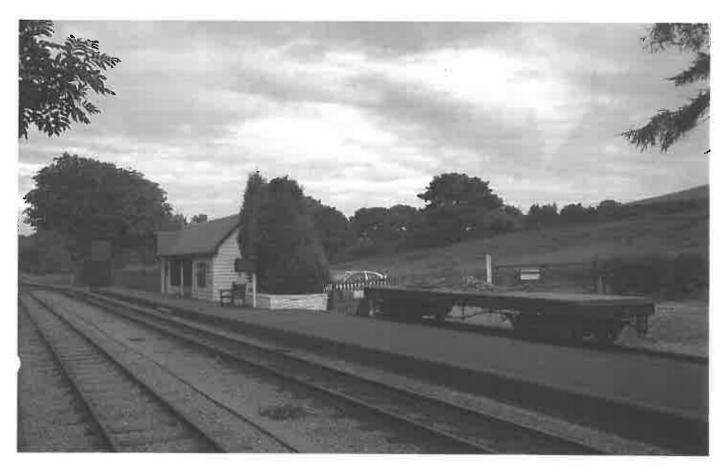
Two general views to capture the ambience of the station site; this photograph is from the Douglas bound platform looking South West.

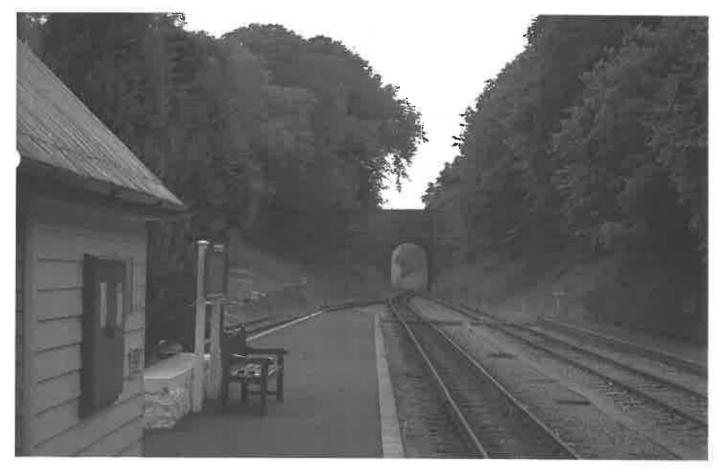
Photograph from the platform looking East towards the main Douglas to Castletown road bridge. Page 7 of 8 $\,$

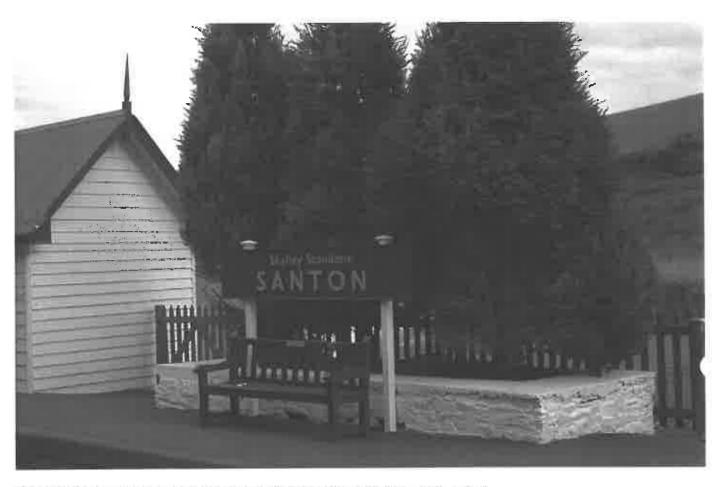
sited on a plinth built from stone. The van was used for station storage purposes for many years before finally being demolished in the early 1970's. The toilet had a zinc tiled roof and originally had brick 'castellations' around the top which had been removed by the late 1970's. The whole block finally succumbed in 1983.

The white stone wall once supported a redundant 'E' van body - see page 1.

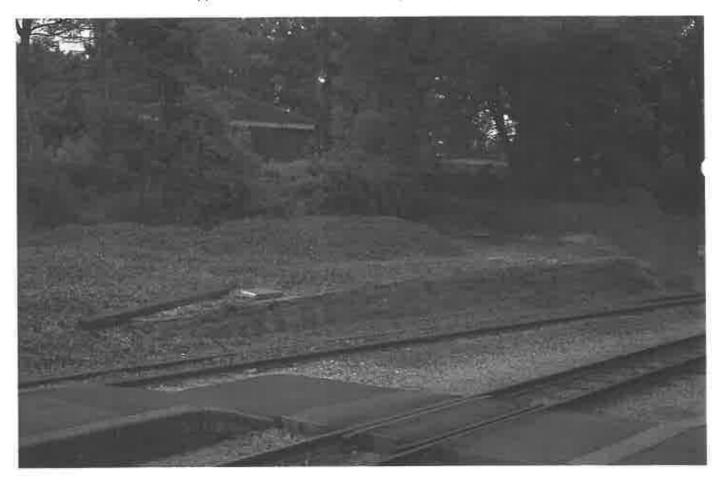
The stone platform was once part of a cattle dock – see page 1 $$\operatorname{Page}\ 8$$ of 8
