**DEPARTMENT OF LOCAL GOVERNMENT AND THE ENVIRONMENT**

**TOWN AND COUNTRY PLANNING ACT 1999**  
**THE REGISTERED BUILDINGS REGULATIONS 2005**

**Ballaradcliffe House Kiondroghad Road Andreas Isle Of Man IM7 3EL**

## REGISTERED BUILDING CONFIRMATION

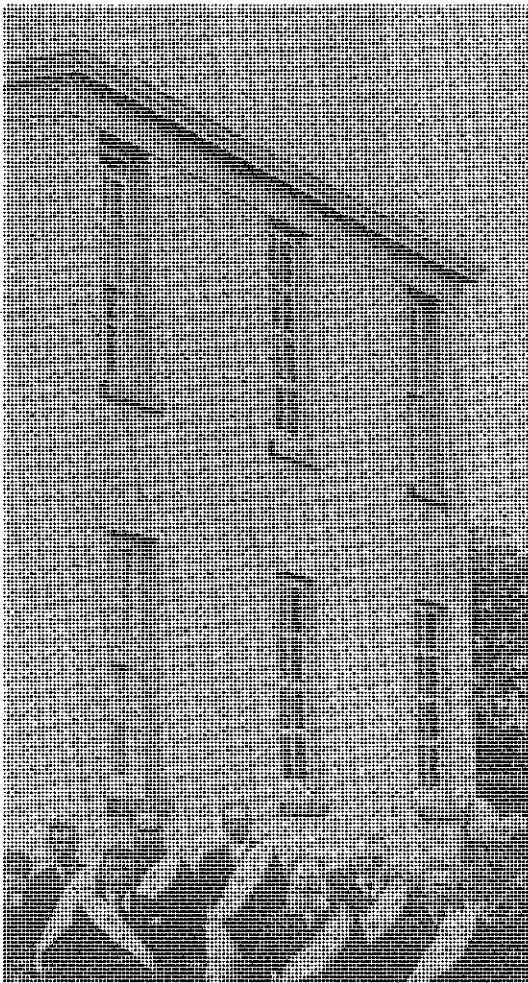
Detail of archive photograph from 1906 showing the three 'dummy' sashes. (Manx National Heritage)

The 1906 photograph reveals an interesting feature of the house in that the three present day blocked windows on the right-hand side elevation (when viewed from the front) initially look like they were once sashes like the rest of the windows. However, on closer inspection it becomes evident that the three 'windows' were flat in appearance and the top sash didn't project out over the bottom sash; this is because these windows were actually painted onto the wall in the recesses.

This process of painting 'dummy windows' onto elevations was commonplace in the United Kingdom during the entire Georgian period, as 'Window Tax' was enforced from 1696 to 1851 and property owners would dodge payment by blocking windows, camouflaging them or painting dummy windows on in order to confuse the inspectors. However, dummy windows are much more unusual in the Isle of Man because Window Tax was never introduced and these fake windows are likely to have been painted onto the elevation for aesthetic reasons, in order to make the building appear more symmetrical. Evidence of painting the fake windows can still be seen in the paintwork today (plate 13). The fake windows on the right hand side elevation are the top centre, the bottom centre and the bottom right. No windows on the front or rear elevations were blocked but there are also blocked windows on the left hand side elevation which were possibly also painted dummy windows at one point, however these cannot be seen in the archive photograph from 1906 and the area is overgrown today so it could not be inspected at the time of this report.
