Kionslieu Reservoir

Discontinuance Feasibility Assessment Report

| Document Title: | Discontinuance Feasibility Assessment Report |
| Project No: | P1077 |

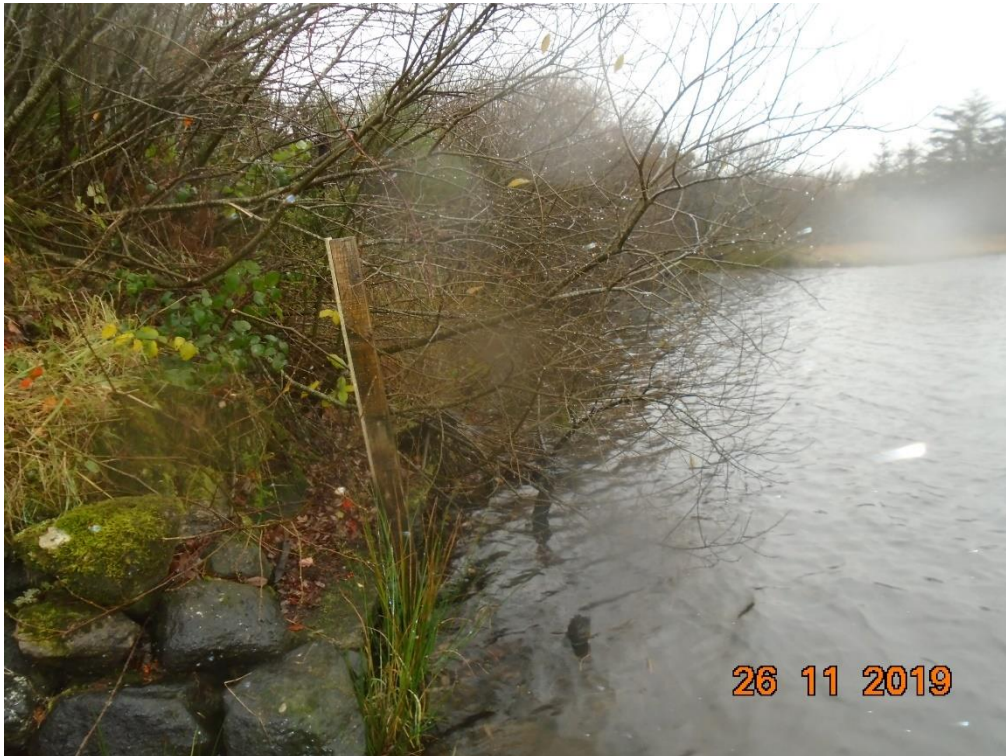
| Feature/consideration | Condition/observations |
|---|---|
| Western Embankment - Upstream face | <i>Heavily overgrown prior to the January 2020 visit. Where face visible, above water level, slope is steep, say 1V:1.5H. On lower sections upstream face is closer to 1V:1H. No signs of movement or slipping. Stone pitching is present generally. Some minor erosion evident from wave action. See Photograph 1 and 2.</i> |

Photograph 1: Upstream face of the western embankment.

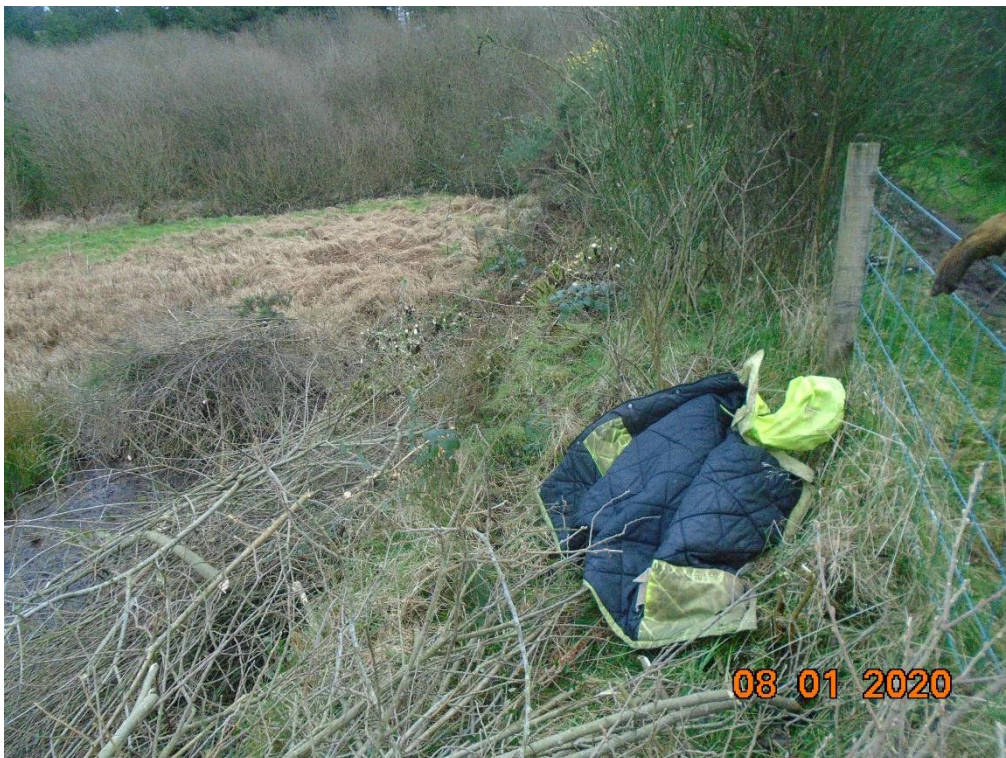
Photograph 2: Upstream face of the western embankment.

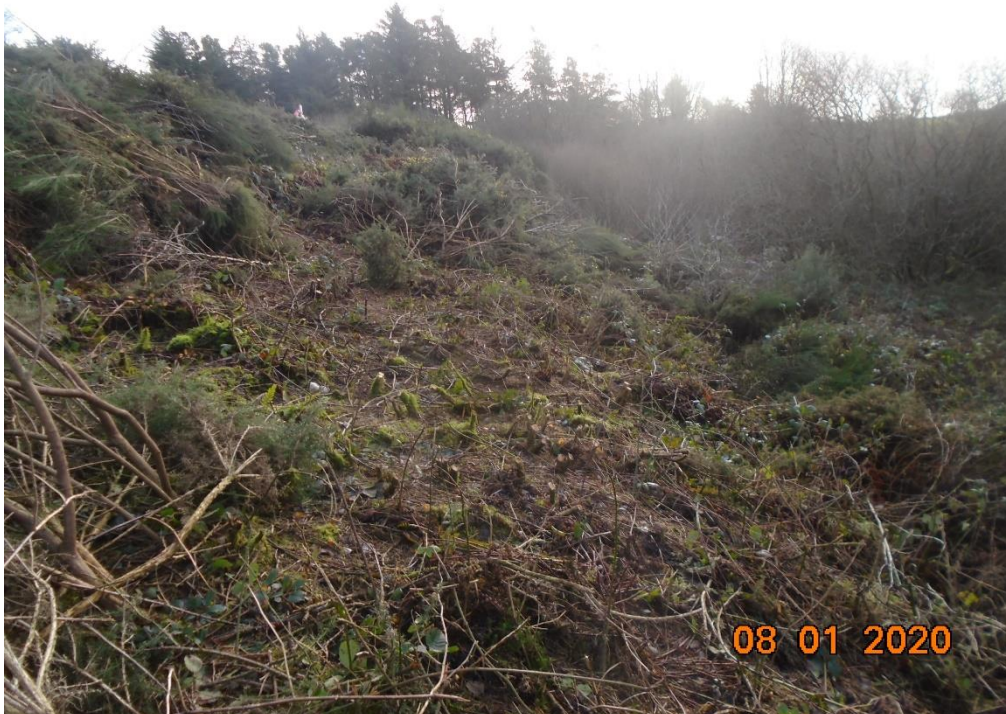
| Feature/consideration | Condition/observations |
|---|---|
| Western Embankment - Downstream face | <i>Not accessible and heavily overgrown at the time of the November 2019 visit. With access available in January 2020 the downstream face generally could be assessed, seen to be steep, say 1V:1.5H typically, and extremely uneven suggesting random placing of fill when constructed. No indications of seepage in the downstream face or toe areas where accessible. Further and closer inspections needed if a retain option is to be adopted. See Photograph 4.</i> |

Photograph 4: Downstream face of western embankment.

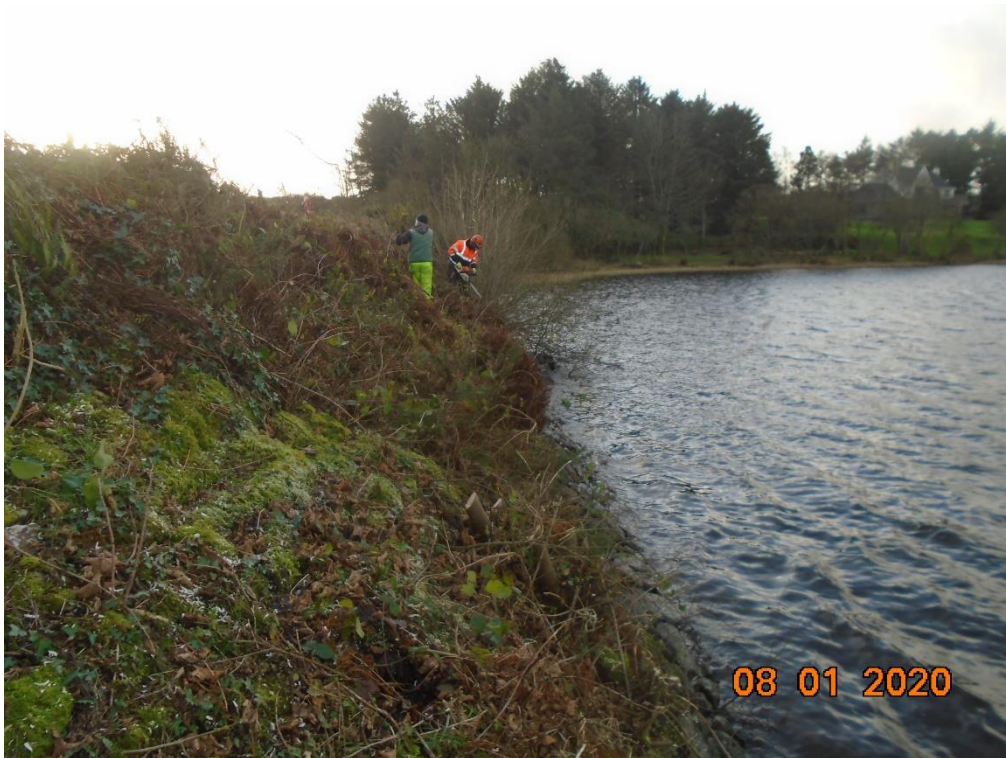
| Feature/consideration | Condition/observations |
|---|---|
| Eastern Embankment - Upstream face | <i>Significant clearing carried out in January 2020 with much of the slope visible, above water level, slope is steep, say 1V:1.5H. No signs of movement or slipping. Stone pitching is present generally. See Photograph 6.</i> |

Photograph 6: Upstream face of eastern embankment.

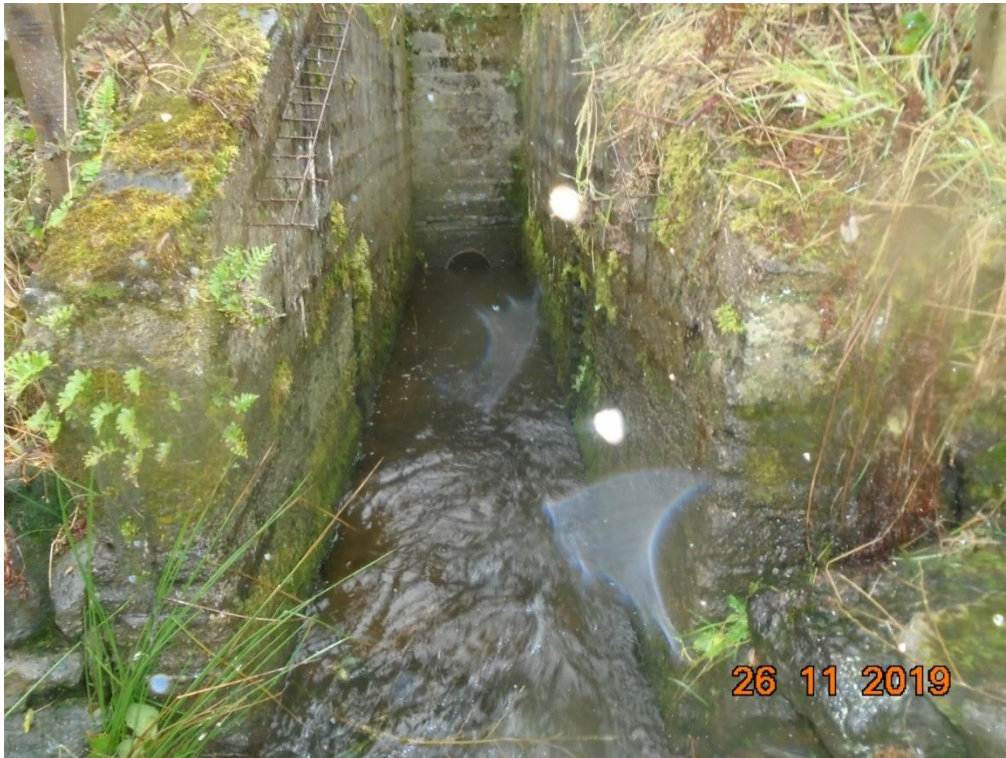
| Feature/consideration | Condition/observations |
|---|---|
| Main Overflow/Outlet | <i>Inlet and outlet clear and operating freely. Upstream end of outlet pipe flowing approximately half full at the time of both visits. Outlet structure headwall constructed of masonry, appears to be stable with no signs of movement. See Photographs 9 and 10.</i> |

Photograph 9: Upstream headwall and overflow/outlet structure.

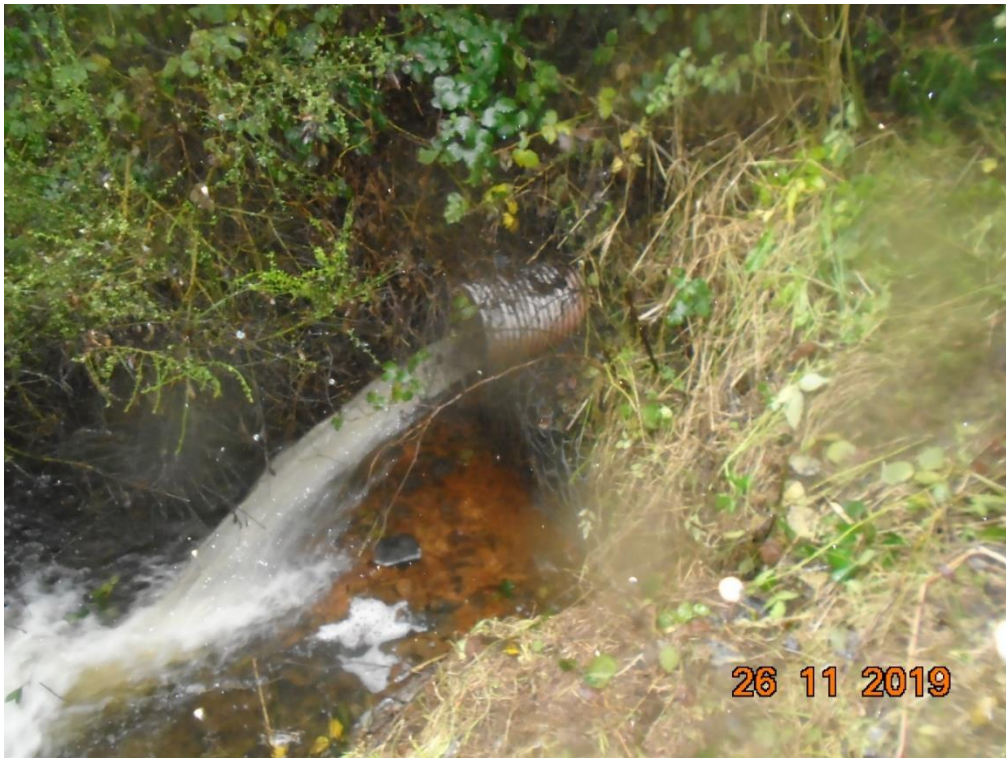
Photograph 10: View of downstream overflow outlet.
