A BRIEF GUIDE TO CONSTRUCTION OF 'CAMBAR' HOUSING IN THE ISLE OF MAN

December 2014

Introduction

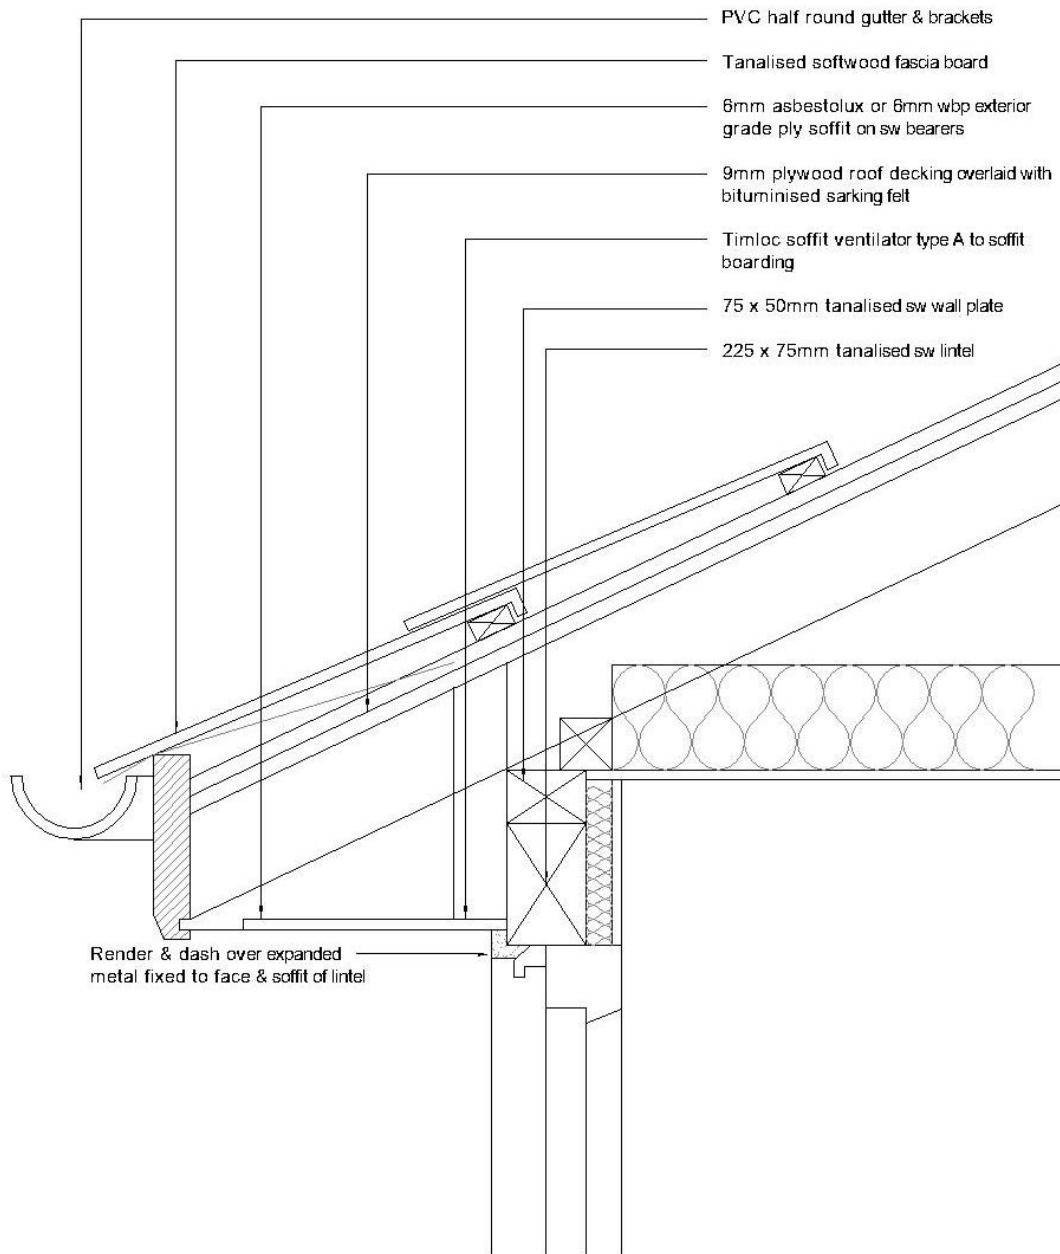
Fig.3.
Roof Eaves Details

Concrete interlocking tiles on battens on bituminised sarking felt on 9mm exterior quality plywood on prefabricated trussed rafters at 600mm centres with 12.5mm plasterboard with 100mm glass fibre insulation material laid over ceiling joists. See figs 3 and 4.

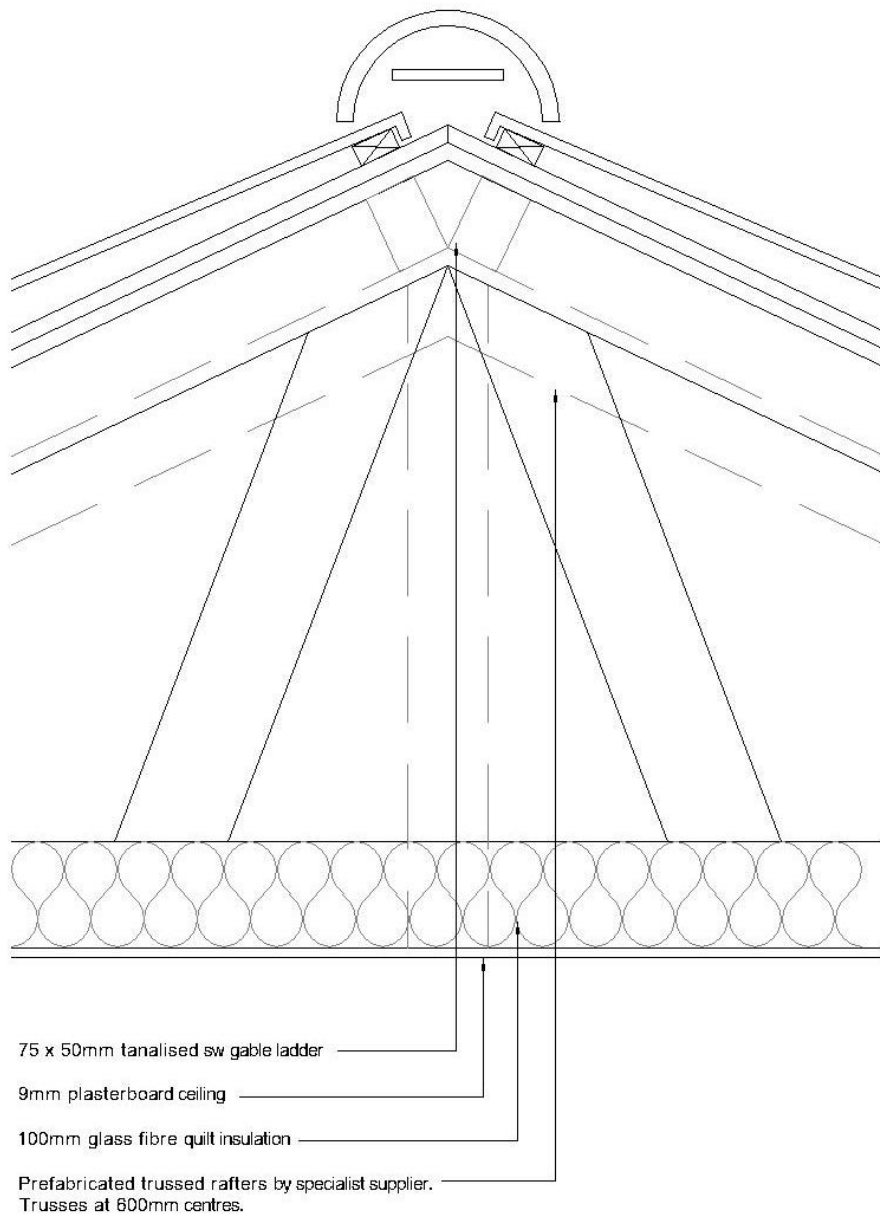
Fig.4.
Roof & Ceiling Details

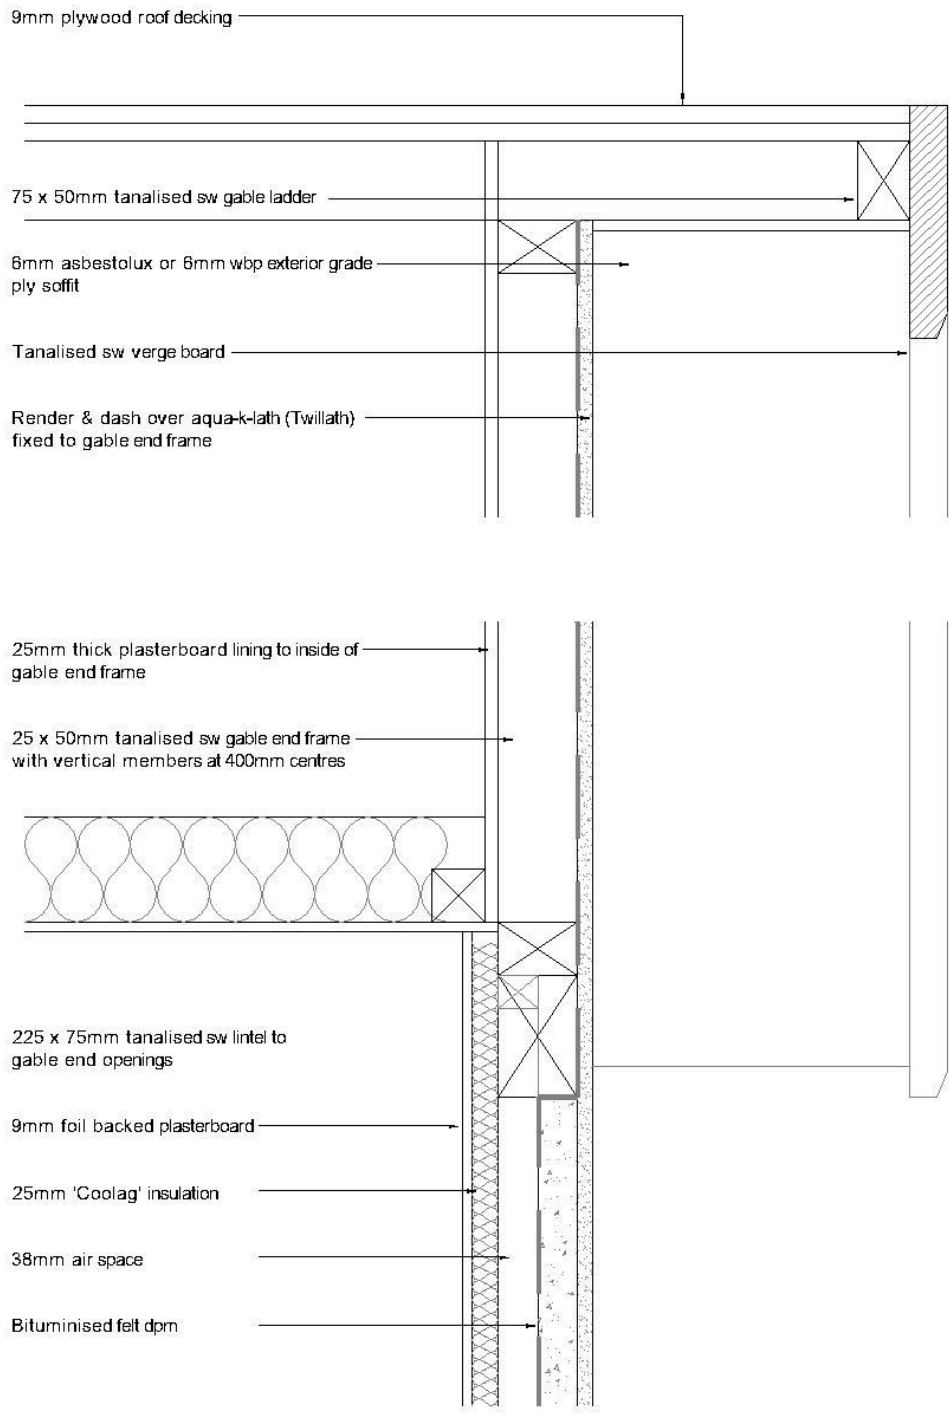
Fig.5.
Roof Verge / Gable Detail

The external walls are made up from reinforced concrete panels of differing heights approx. 400mm wide and 38mm thick fixed onto 38mm x 32mm tanalised soft wood timber framing. See Figs 5 and 6.

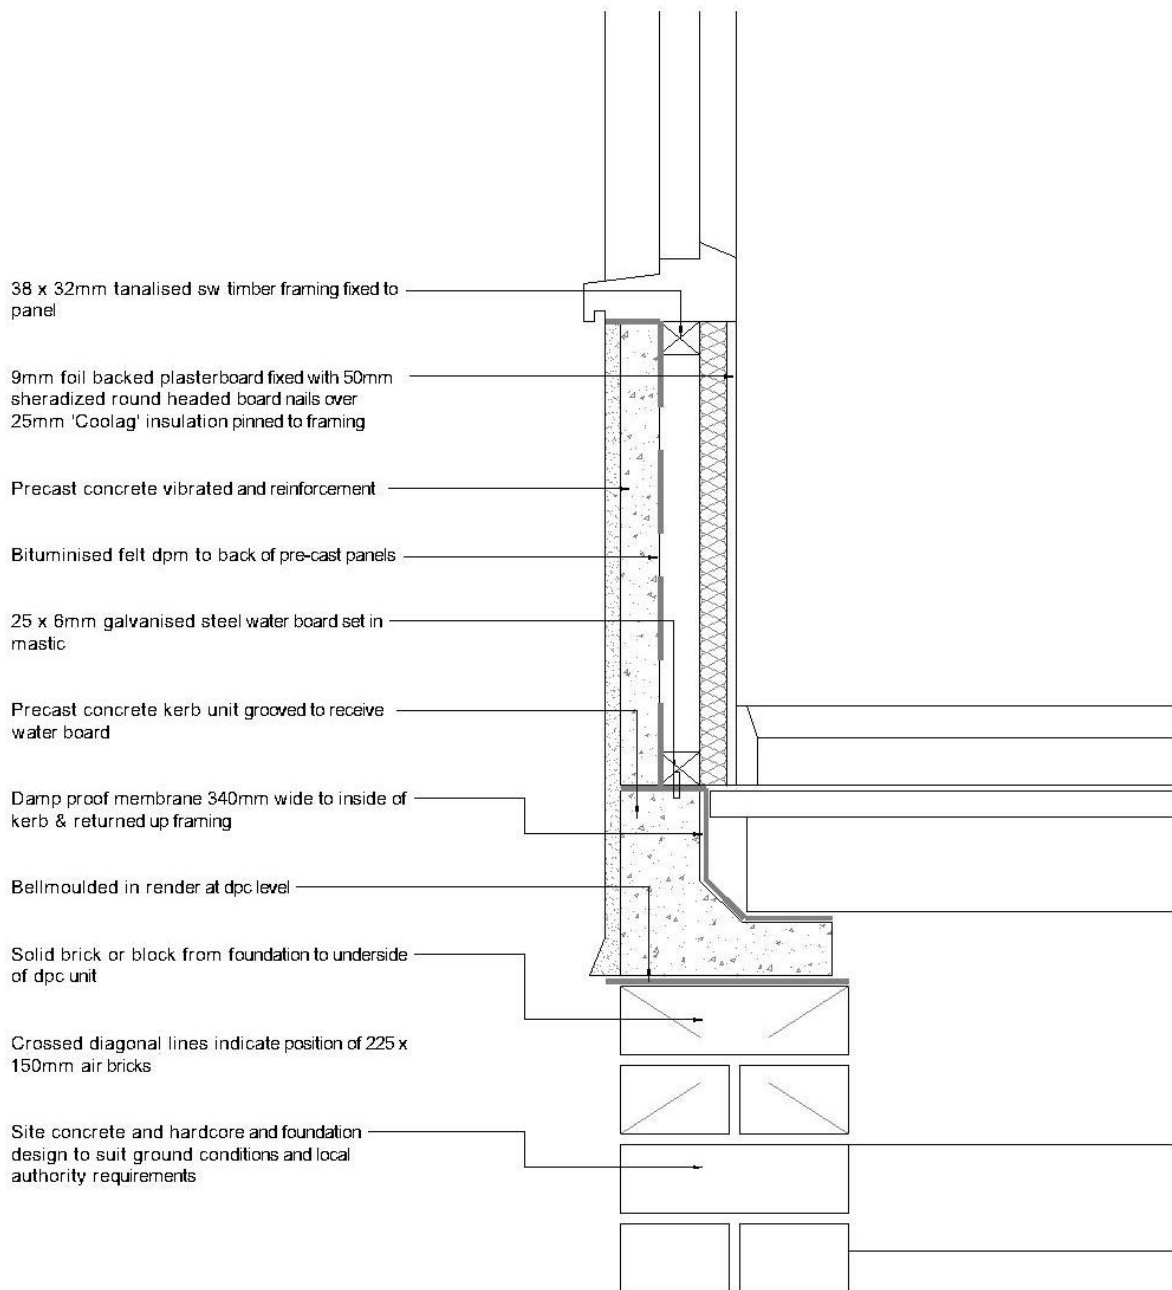
Fig.6.
External Wall & Foundation Detail

- foundation designed to suit the local ground conditions, see typical details Fig 6;
- precast reinforced concrete panels manufactured under controlled factory conditions;

Foundations are generally 500mm wide x 225mm deep cast in-situ concrete strip footing with a minimum of 230mm brick work supporting the main loadbearing components.

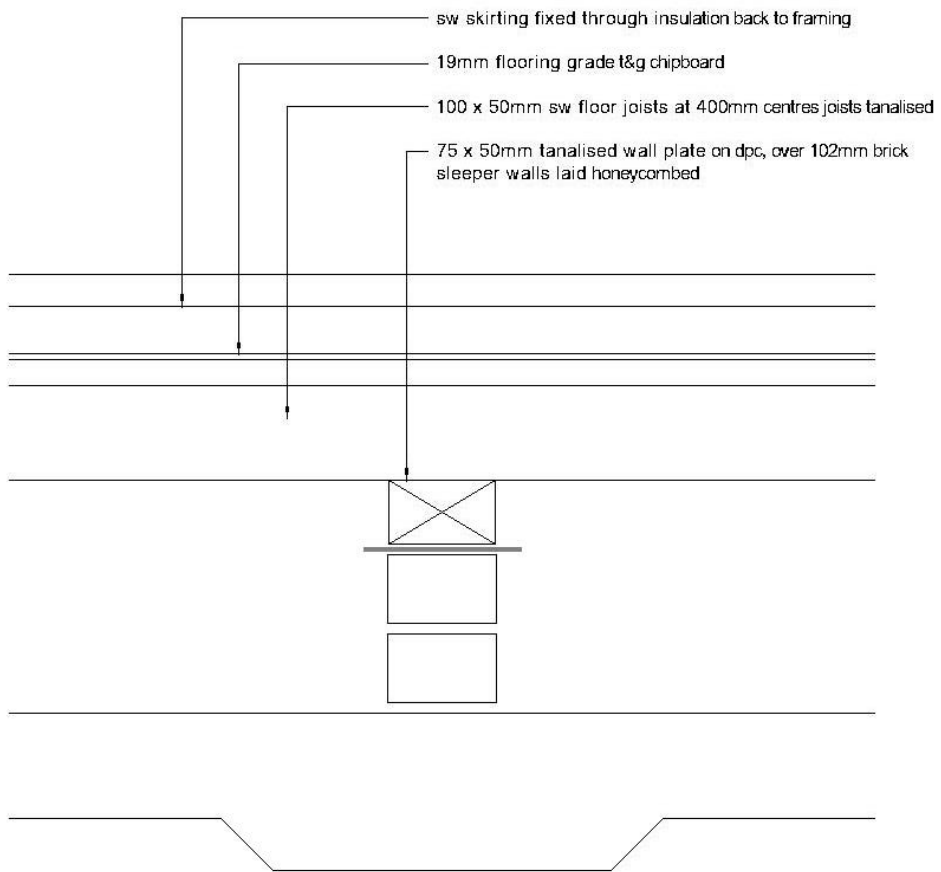
Fig.7.
Floor & Sleeper Wall Detail

19mm flooring grade T&G chipboard on 100mm x 50mm joists at 400 centres on 75mm x 50mm tanalised, (preservative pressure impregnated) wall plate on DPC over 102mm honeycomb brick sleeper walls. See figs 7 and 8.

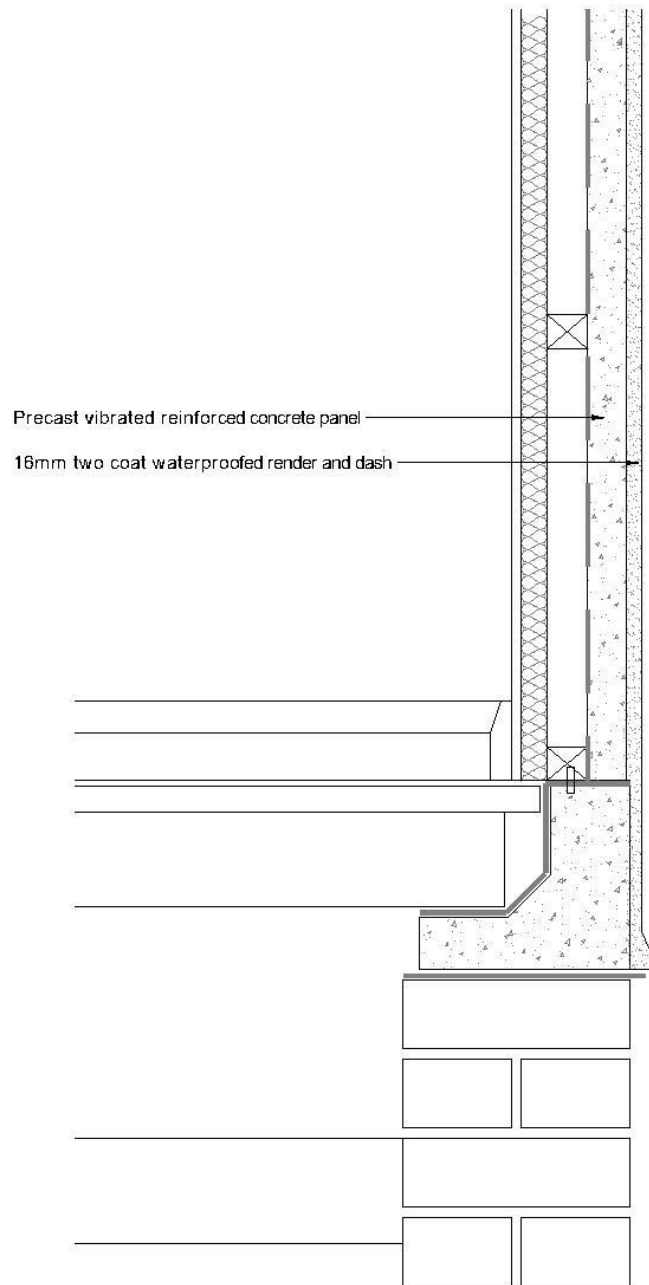
Fig.8.
External Wall Detail

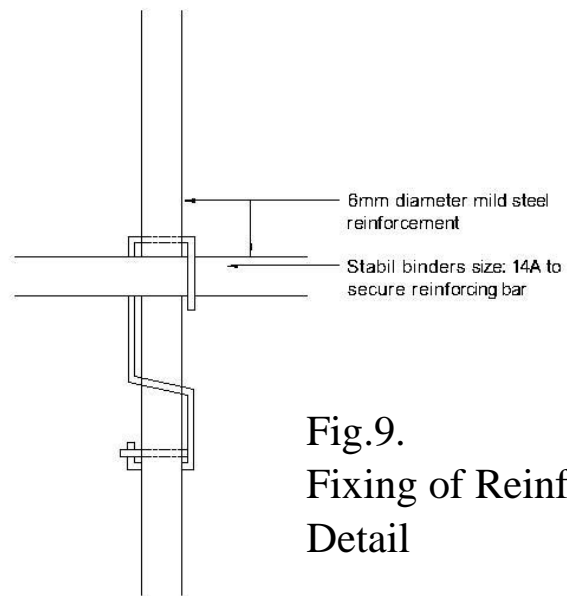
Fig.9.
Fixing of Reinforcement
Detail

6mm diameter mild steel reinforcement in 38mm thick vibrated concrete panels fixed with zinc plated cut square full threaded CW hexagonal nuts, bolts and zinc plated washers with fixing clamps to timber framing. Butyl Sealant mastic applied to all panel joints. See Wall Unit Detail Figs 9, 10 and 11.

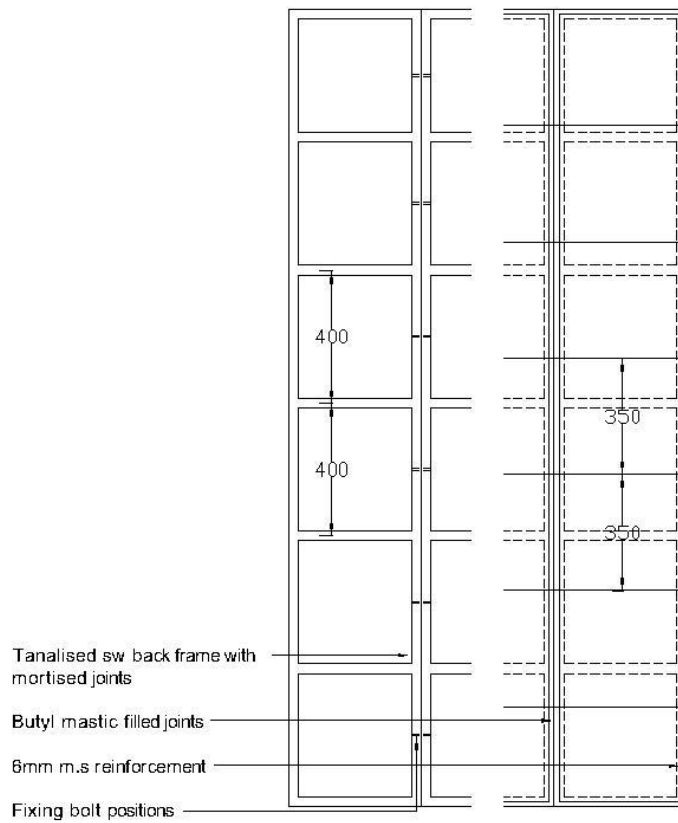
Fig.10.
Rear of Panel

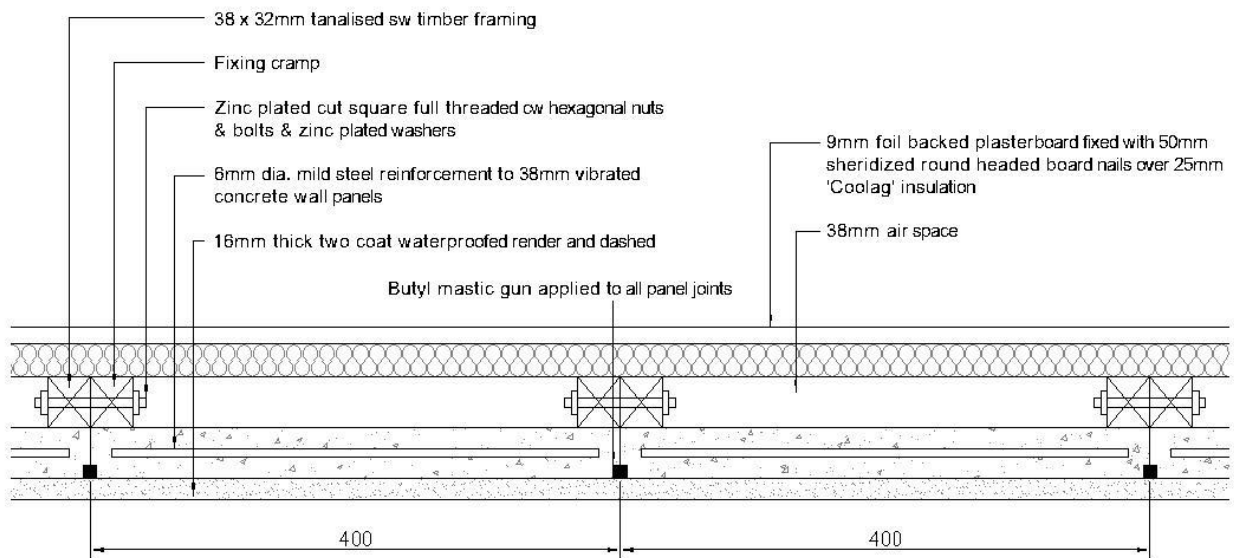
Fig.11.
Wall Unit Detail in Plan

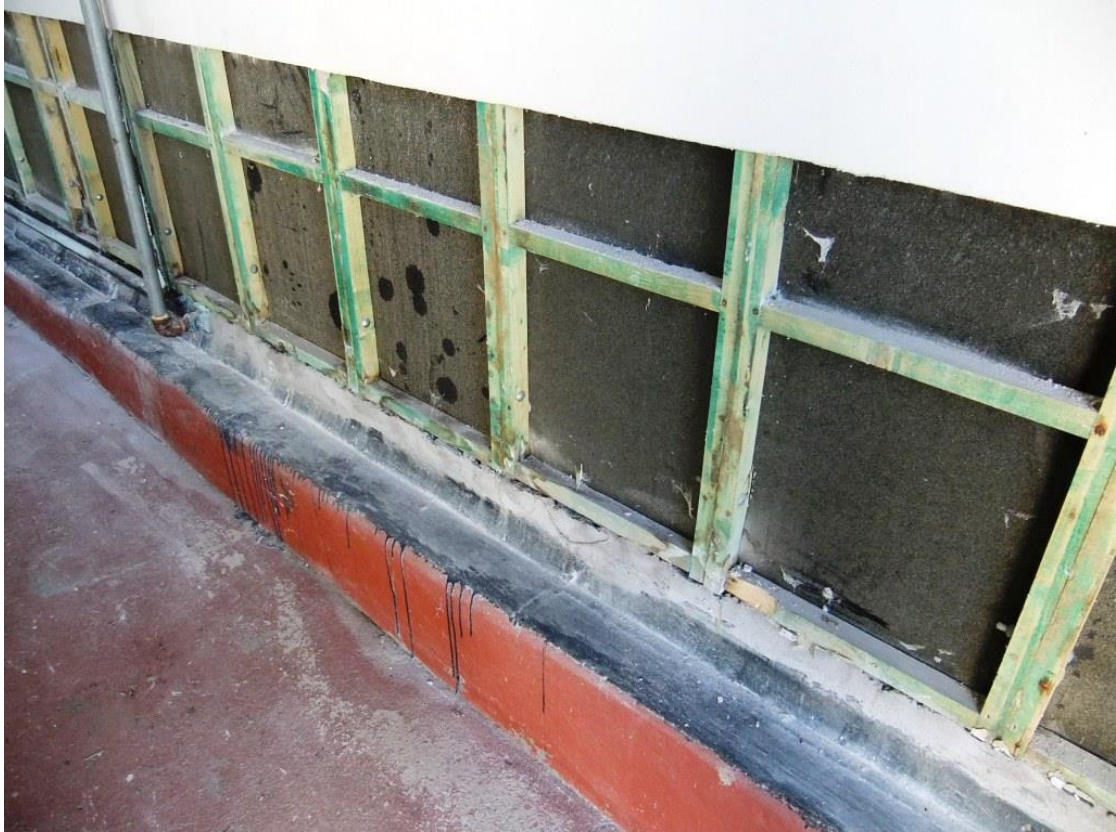
Garage external wall panels exposed during alterations in 2014

Precast reinforced concrete panel houses constructed in the Isle of Man developed from Dorrán/Mantis systems for the main load bearing walls. Floor and roof are of traditional timber construction. The vast majority of these were built in accordance with 1976 Building Byelaws applicable in the Isle of Man at the time of construction. The Isle of Man adopted England & Wales Building Regulations in May 1993. The concrete panels were cast in factory conditions and in various lengths and taken to site once cured and ready for assembly on site. There have been no reported failures or significant problems associated with 'Cambar' buildings in U.K. or the Isle of Man to date. In fact recent works to extend some properties have revealed the robustness of the original construction (see pictures page 18).

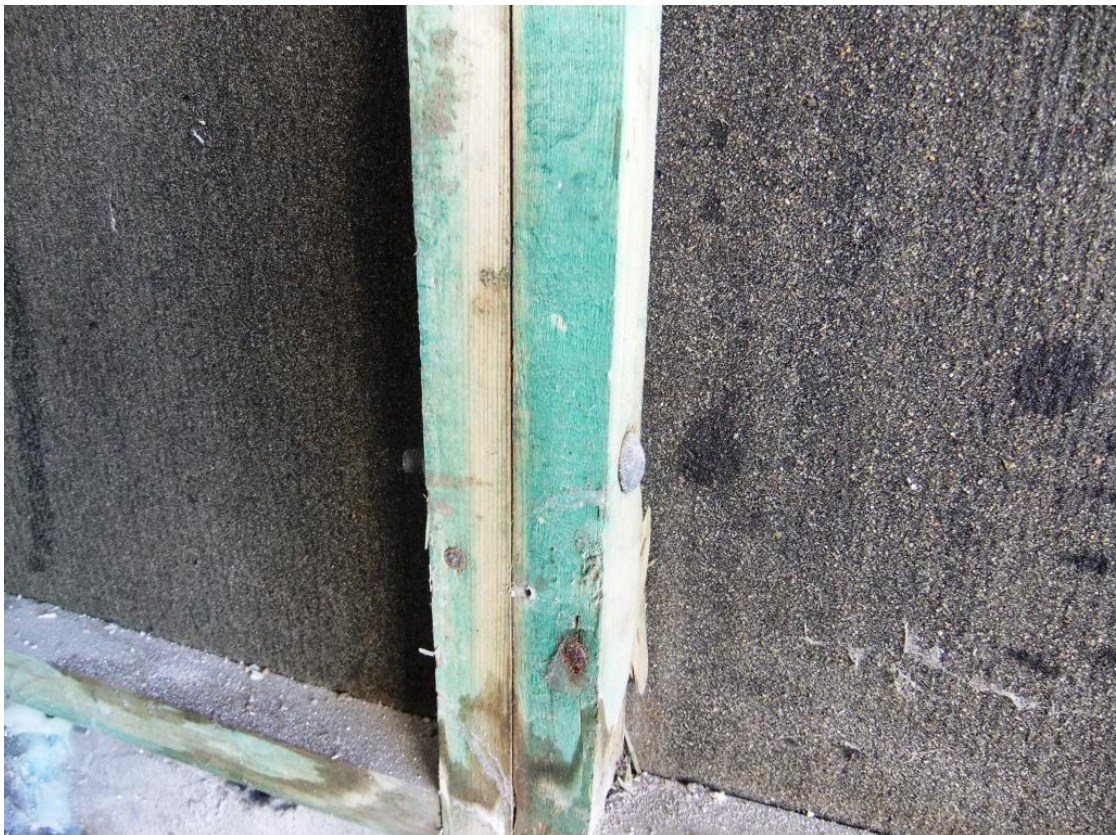
Garage external wall panels exposed during alterations in 2014
