Isle of Man Harbours and Tubeworms

We have identified a non-native species of Australian tubeworm (*Ficopomatus enigmaticus*), also known as trumpet tubeworm, or coral worm, on the hulls of several vessels that have recently been lifted out from **Peel Marina** for winter.

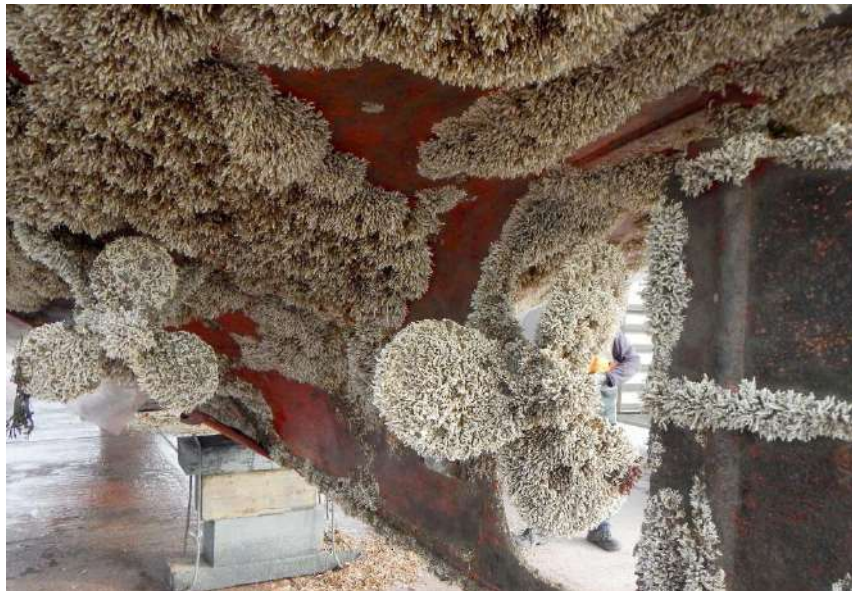
Extreme Australian tubeworm fouling at Southampton (Image: Rob Holland)

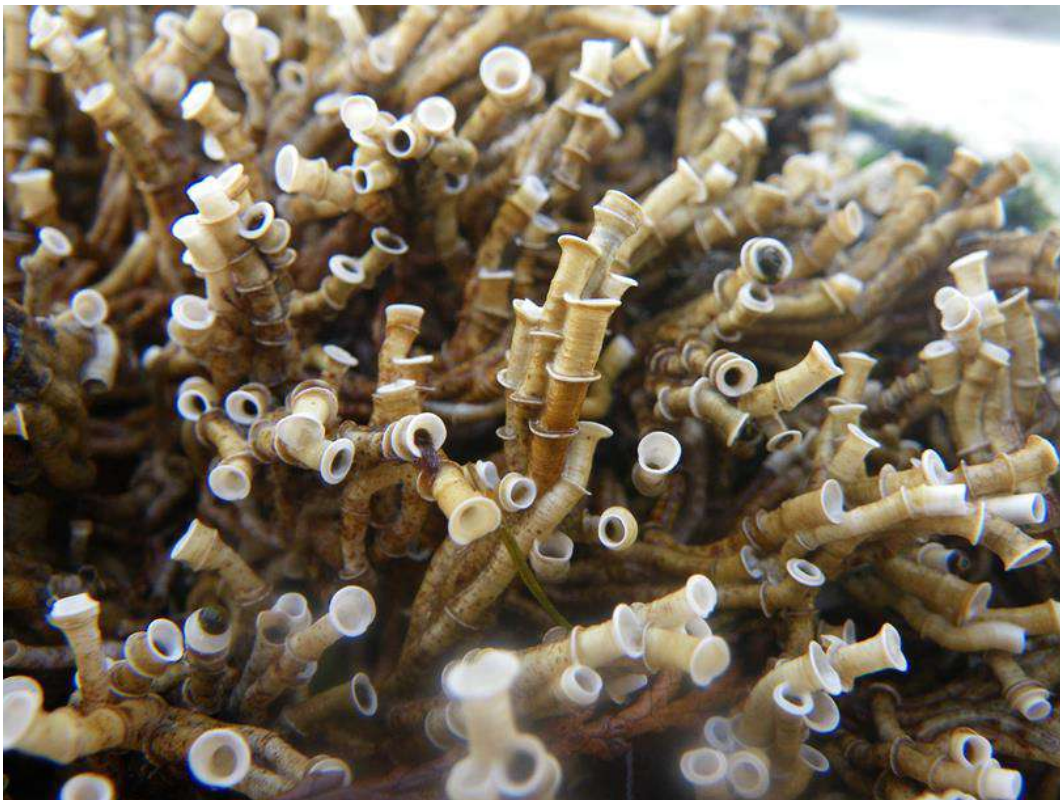
Close up of Australian tubeworm showing flared ends, white collars and light brown colour
(Image: John Bishop, MBA)

- The images in this document show the main identifying characteristics of the tubeworm;
- Like many species of tubeworm, this species has **calcified (chalky) tubes around 1-3mm in diameter.**
- However, the invasive tubeworm also shows the following characteristics;
 - **Light brown colouration**, especially on recently-formed tubes and most visible when growth extends outwards;
 - Distinctive **white collars** on the tube (may be less obvious on flat growth form);
 - Distinctive **white flaring (trumpet shape)** of the end of the tube
- The tubeworm can form dense clumps of long extended tubes on some structures, especially if left undisturbed (see images). However, when the colony is new, or in disturbed conditions, the tubes may be sparse and flat – however the **three specific characteristics noted above** should still be visible.

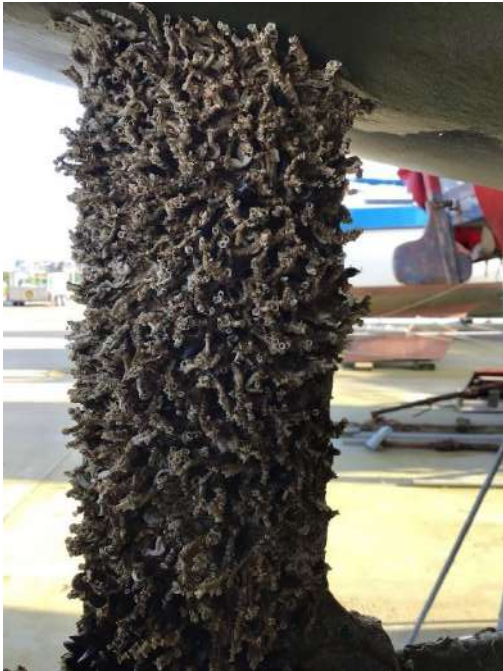
High profile (extended) form: mature colony growth with extended long tubes on metal parts of vessel steering/propulsion system. (Image: DEFA)

Australian tubeworm likes to settle and grow on exposed metallic objects such as propellers, shafts, outdrives, anodes and skin fittings. Growth on fibreglass hulls is limited but can be found in severe cases. Not all vessels are equally affected and so far we have seen variable

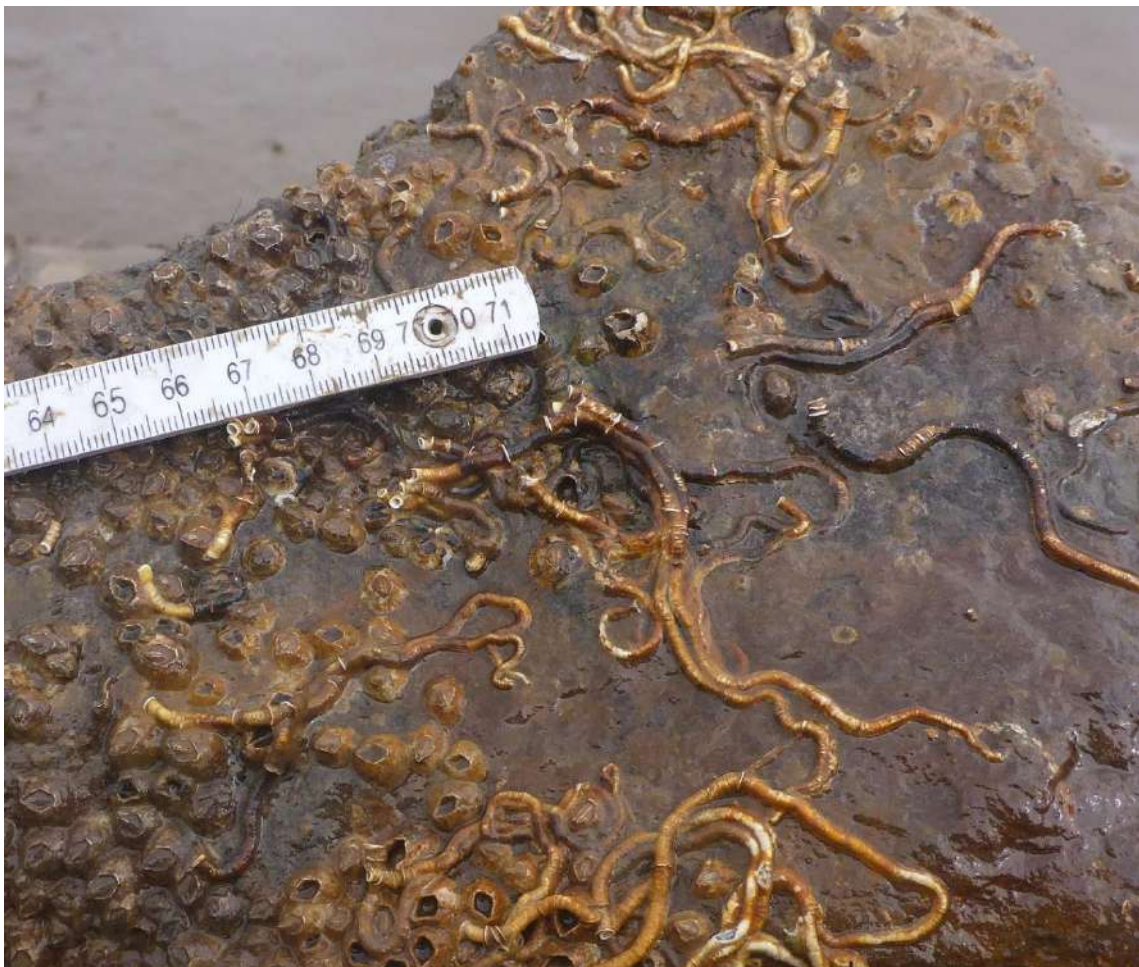
Low profile (flat) form: Australian tubeworm in early stage or disturbed-environment, but characteristics are still visible. (Image: John Bishop, MBA)
