Turkeyland Recycling and Waste Management Ltd

Review of 2021 waste testing
and water quality monitoring data

March 2022

TRWM: Review of 2021 waste testing and water quality monitoring data

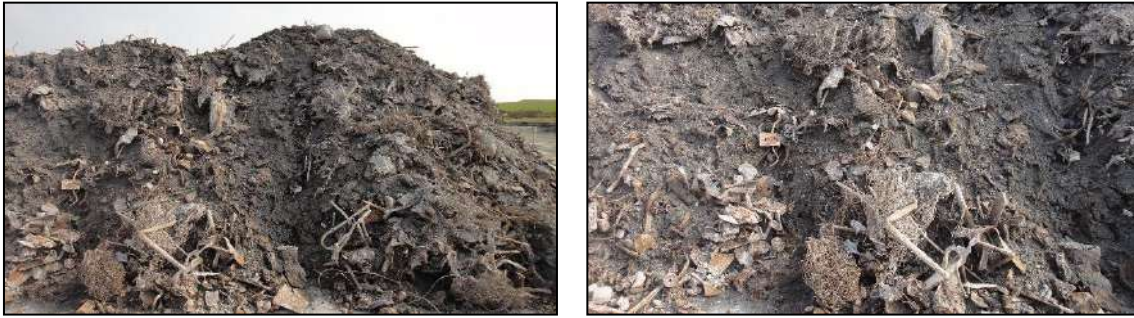
Plate 1. Raw IBA, no metal segregation, on Old Turkeyland maturation pad. April 2019 Rain falling on the maturation pad is routed to a run-off collection sump. This is a covered concrete tank buried in the ground adjacent to the north west corner of the pad. From here it is pumped to discharge to a sea outfall, under licence.

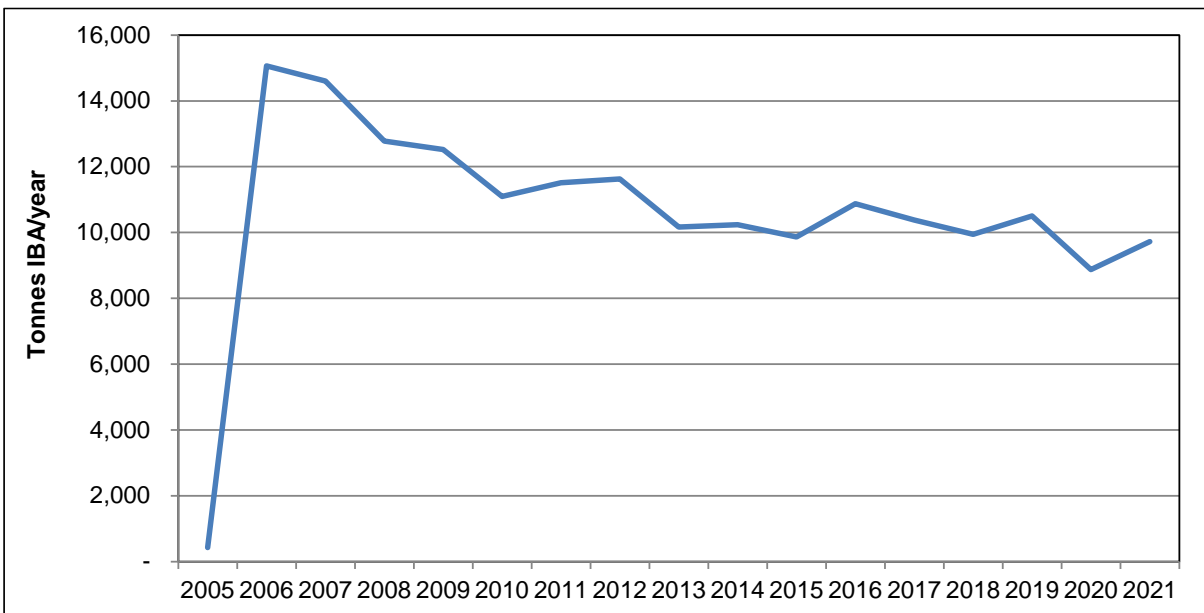
Figure 1-1 Annual quantities of untreated incinerator bottom ash delivered to Turkeyland

The processing facility began operations during 2012. From then on all IBA delivered to Turkeyland has been subjected to the maturation process. The annual tonnages of IBA delivered to Turkeyland since the start of the Richmond Hill EfW plant are shown in Figure 1.1. These declined steadily by ~30% from 2006 to ~2013. This is thought to be due to an annual escalation in the gate fee, which was understood to be £165/tonne by early 2016. Between 2013 and 2021 tonnages appeared to have stabilized at ~10,000 tonnes per annum, Monthly inputs varied considerably from highs of over 1,000 tonnes per month in January, March and July to less than 400 tonnes in February and May.

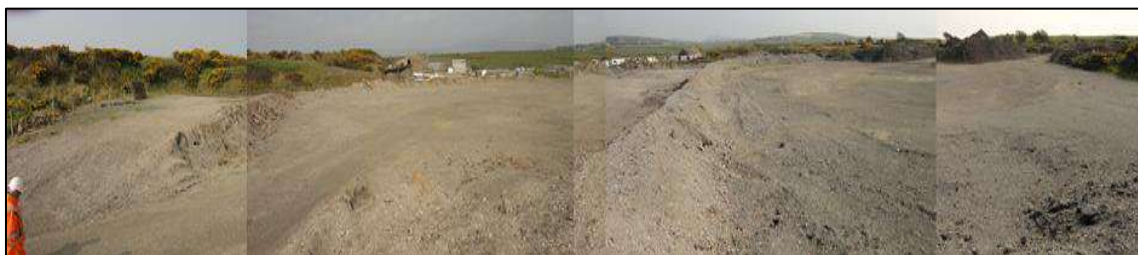
Plate 2. View of OTL cells following removal of IBA to NTL (April 2019)

From December 2016 to late 2017, processing of the OTL ash to recover metals was undertaken, by a Danish company, Meldgaard. This has resulted in ~79,000t so far having been transferred into NTL after processing. In some parts of the site IBA has been completely removed down to the BES basal layer. There is estimated to be ~30,000t remaining in OTL since the end of 2017.

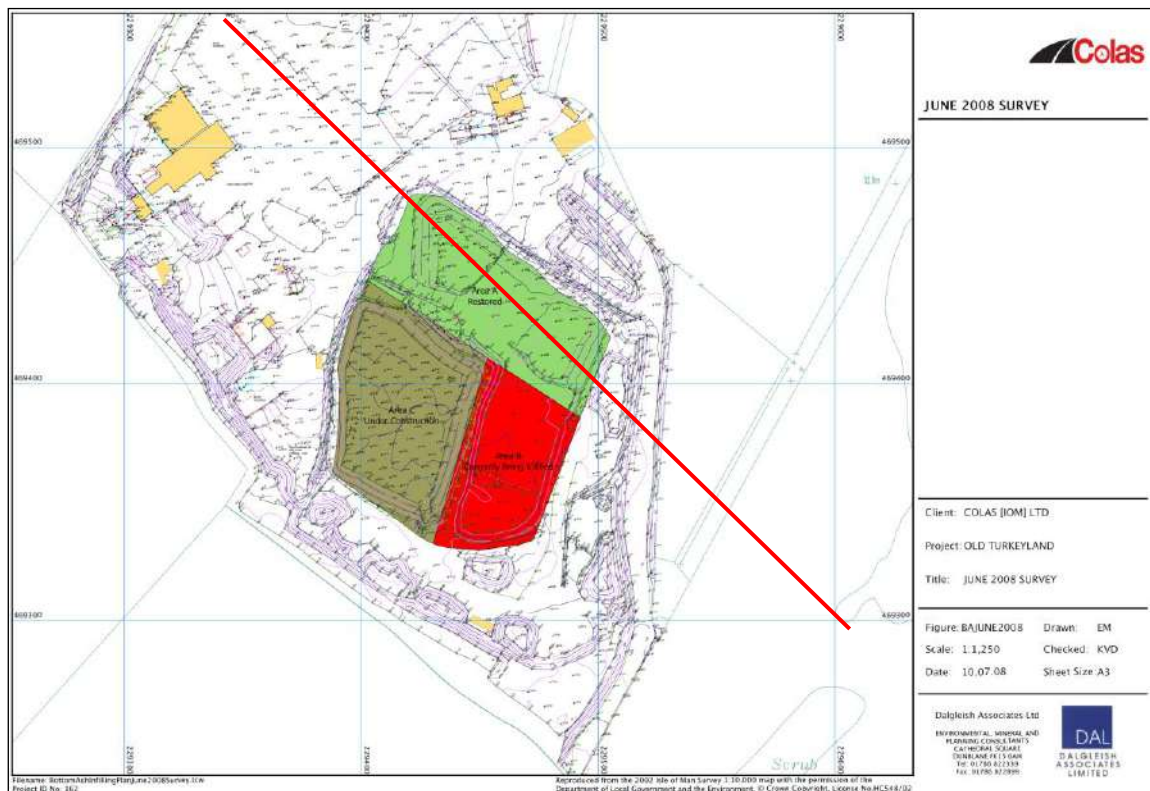
Figure 1-2 Layout of OTL landfill cells A to C, for IBA disposal, as at June 2008

[Source Dalgleish Associates Limited]; approximate line of section shown in red

Cells A to C were lined with bentonite-enhanced sand (BES) to minimise basal leakage. It is understood that at the design stage it was anticipated that no leachate would accumulate within the cells and that leachate discharge would not be necessary. The cell design did not include provision of basal drainage layers or abstraction sumps. There was no hydraulic separation between the cells. The base contours of each cell are graded at a fall towards the north west, of 1 in 200. Between Cells B/C and Cell A there is a step down in base level from ~30mOD in Cells B and C to the base of Cell A which grades from ~29mOD in the south east, to ~28.5mOD in the north west.² The base plan shows a low point in the northern corner of Cell A at ~28-28.5mOD.

While the monitoring wells were in use, leachate levels rose and fell seasonally in each cell: it was noted above that there is a low point in the northern corner of Cell A, at ~28 - 28.5mOD, whilst the Cell B and C bases grade towards Cell A without any impediment. It therefore appears likely that seasonally accumulated leachate may have been able to drain slowly from the three cells via a low point on Cell A. From there it would have had the potential to contaminate surface waters. The removal of much of the ash means that this risk should have been reduced. Nevertheless if IBA remains in place in OTL it is **recommended** that a more formal leachate collection sump is installed and operated to reduce any uncontrolled seepage.

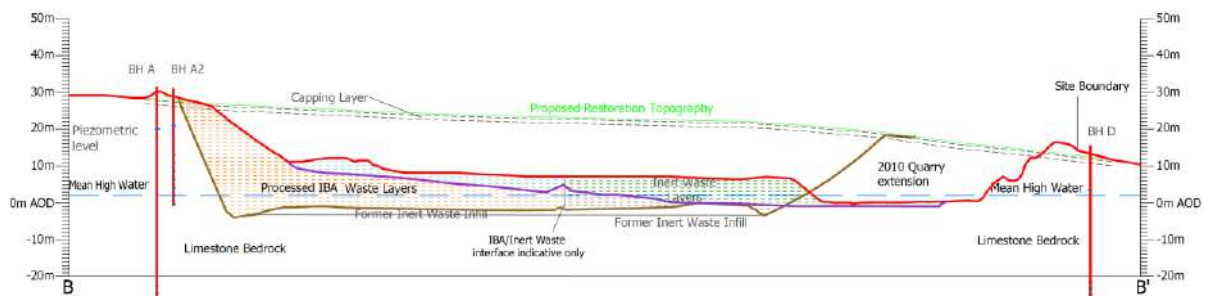
Figure 1-4 Schematic cross section of NTL landfill, approximately NW to SE

[Source: Dalglish Associates Limited; Cross-section adapted for this report]

This is an unlined quarry located in fissured limestone. The deepest part of the quarry base lies at -4mOD, which is well below the inferred rest water level for the local groundwater system. The quarry has been maintained in an un-flooded condition by dewatering. It is understood that under rest conditions, when hydraulic equilibrium has re-established, groundwater in the vicinity of the quarry is likely to discharge into the marine waters to the east of the quarry. A cross section from the survey carried out in September 2020 is shown as Figure 1.4, with annotations showing the waste profile at that time, the inferred original quarry base level and current piezometric levels from Boreholes A and A2 up-gradient and D down-gradient of the quarry. In 2004 the original useable airspace for wastes to approved final contours was calculated to be 641,994 m³. This includes an allowance for 5% settlement and excludes volumes of soil to create a 0.5 m thick cover layer.

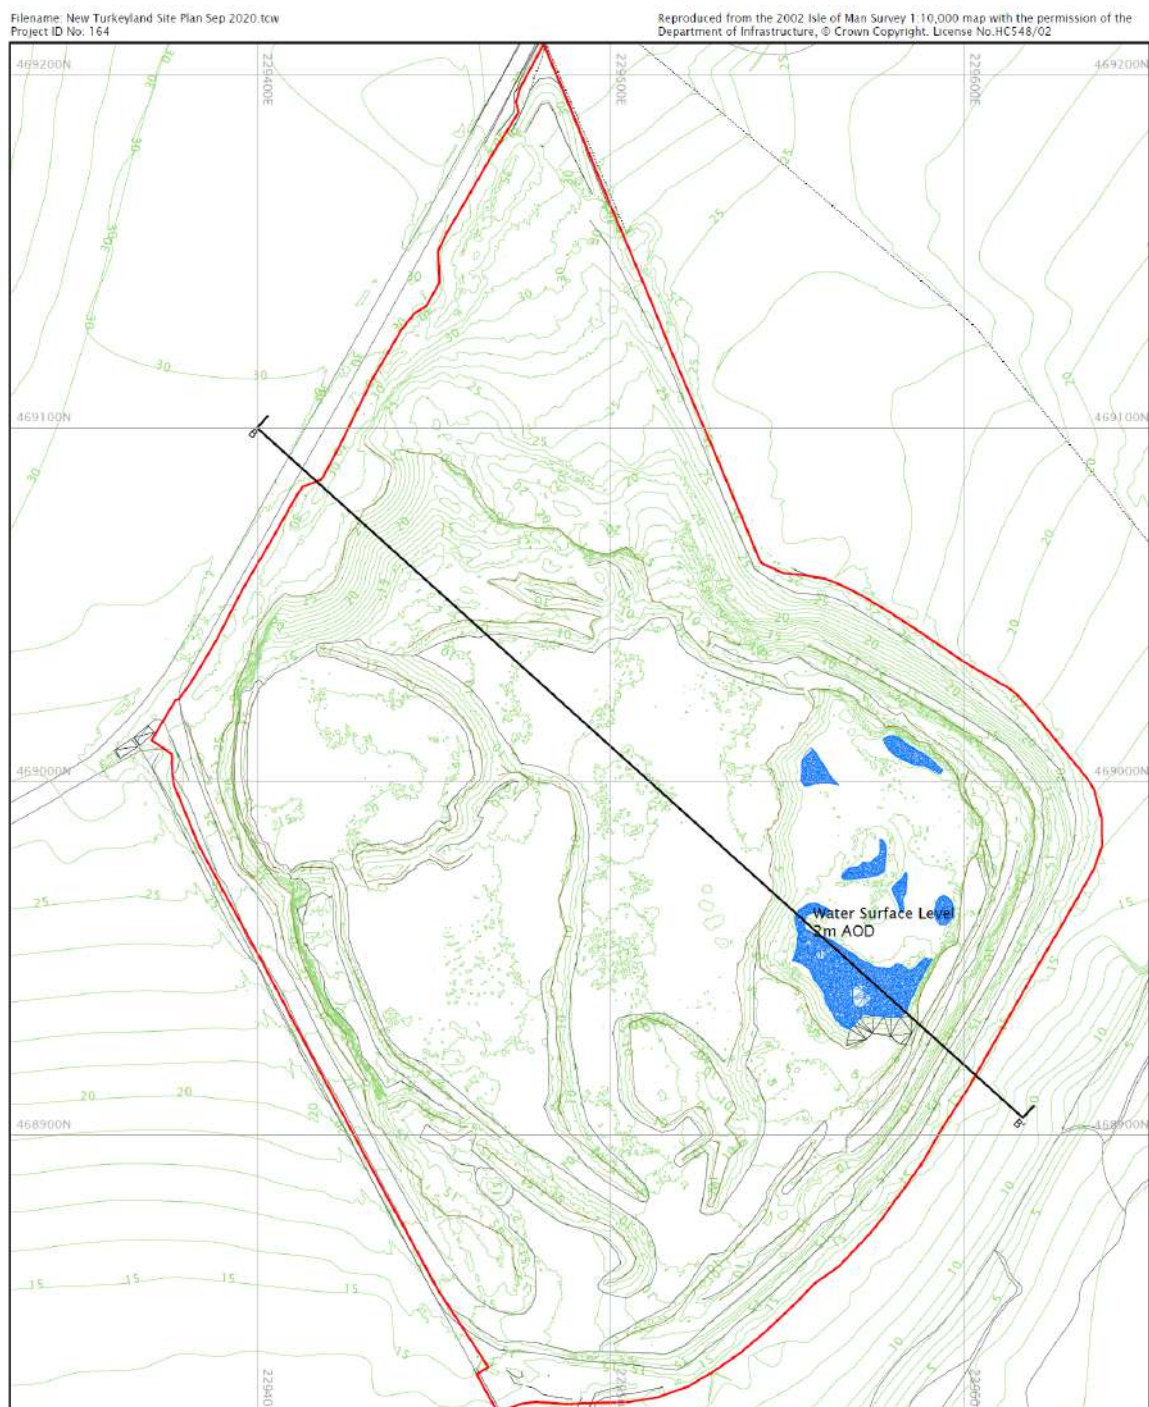
Figure 1-5 Topographic survey of NTL landfill as at September 2020

[Source: Dalgleish Associates Ltd Dwg 'Site Plan September 2020', dated 21.05.21]

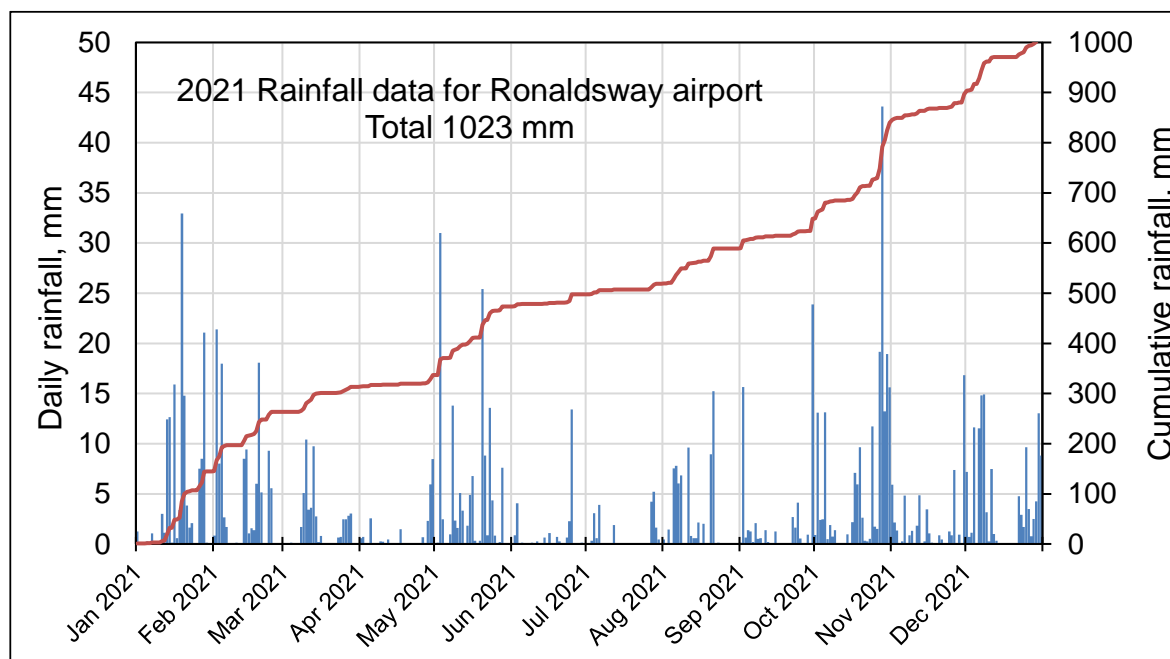
Figure 5-4 Daily and cumulative rainfall data for 2021

Data source: Isle of Man Meteorological Office

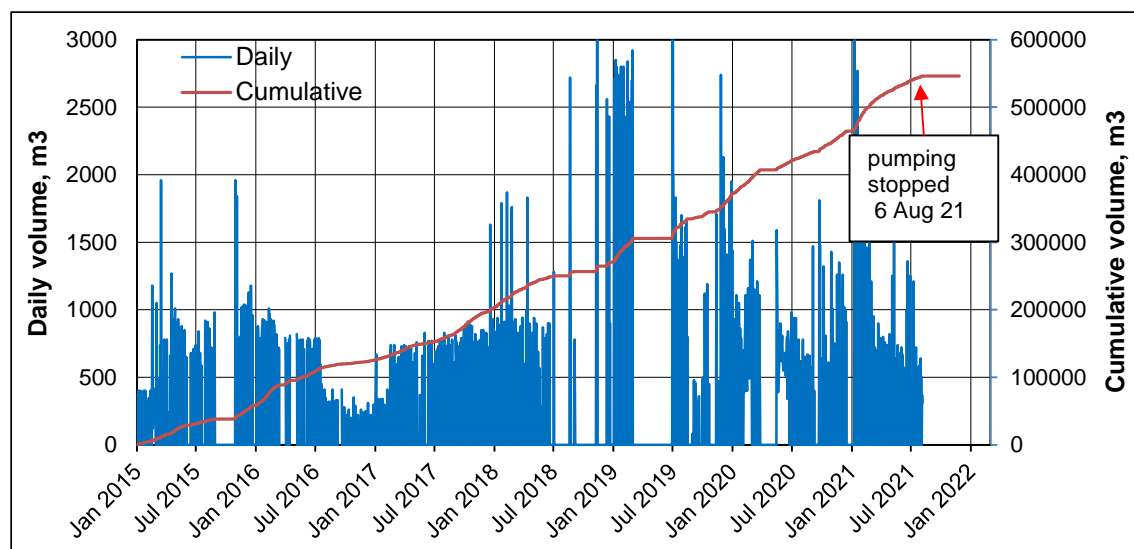
Figure 5-5 NTL quarry sump discharge volumes

In 2021, the pump operated on 137 days, for an average duration of ~ 3.2 hours. On 60 days over 600 m³ was pumped, with a maximum daily discharge of 3020 m³.

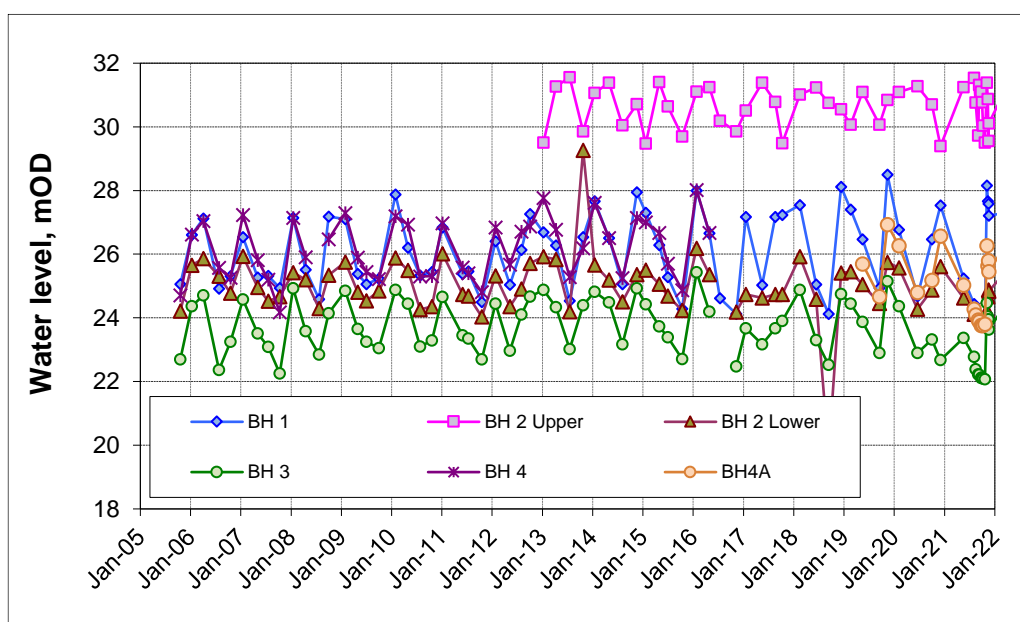
Figure 6-1 Time series water level data for groundwater boreholes at OTL landfill

In the bedrock, the highest groundwater levels are in the two westernmost boreholes, BH1 and BH4 (whilst in operation) and the lowest at BH3 to the northeast of OTL. The level data therefore imply a piezometric gradient in an approximately north easterly direction, towards Santon Burn. There is no obvious effect of dewatering of NTL quarry (at times over the historical period down to -3mOD) on levels at BH1 which is nearest to NTL quarry.

Groundwater levels in the four bedrock boreholes are all lower than leachate levels used to be in the OTL landfill (Figure 5.1), which fluctuated between ~29.4mOD and ~30.8mOD until the ash was largely removed. Therefore the potential existed for downward migration of leachate leaking through the basal liner. Conversely, groundwater levels in the superficial deposits (BH2 upper) are at most times within a similar range to the historic OTL leachate levels, rising slightly higher than leachate levels did in the winter, so little potential existed for contamination from OTL leachate.

16. **Groundwater levels around OTL landfill** undergo a regular seasonal fluctuation of from 1m to 3m. There is no evidence of any long term change. In the four bedrock wells, water levels are consistently lower than leachate elevations were in the landfill. Therefore, there was potential for downward movement of leachate. However, water levels in the single borehole in the superficial deposits (BH2 Upper) are at most times within a similar range to leachate levels, rising slightly higher than leachate levels in winter. This implies no potential for leakage of leachate into the superficial deposits, and therefore perhaps little or no actual potential for leakage into the bedrock.
